Chapter 6

Study of Charcoal Mounds and Kilns

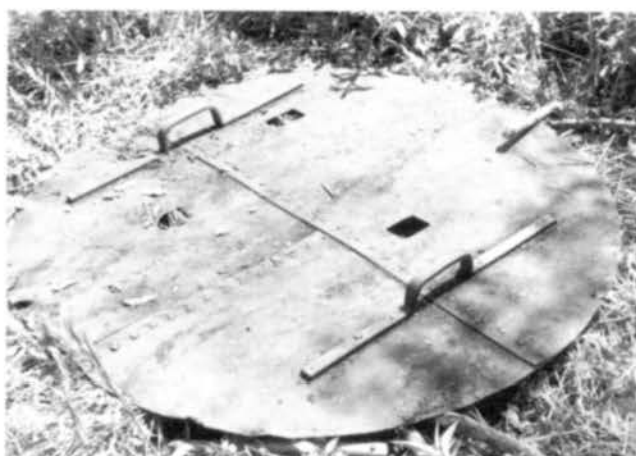
6-5. One variety of charcoal kiln top-loading-hole cover at Old Job.

Variability in design of hardware for charcoal kilns was also obvious in the configurations of the round covers that closed the top charging holes by laying flat on the round holes in the tops of the kilns. These 6- to 7-foot-diameter by ½-inch-thick iron covers displayed varieties of vent holes. Most covers had nearly brick-size holes cut lengthwise into the cover so the holes could be closed simply by bricks laying flat on them. One cover found at Peru had holes with small, sliding iron doors that could be opened and closed to control the draft allowed to enter the kiln through these top vents. A few covers had no holes at all. Cover handles varied from pairs of U-shaped

iron units bolted or welded to the covers to U-shaped sections of long iron bars that reinforced the entire diameters of the covers (similar to variations of handle designs on the large iron doors). Probably because of their round, flat shape, these covers escaped detection of scavengers. Except for their uniquely shaped iron doors, no hardware was found associated with stone-type kiln ruins because their beehive design created a much more stable structure.

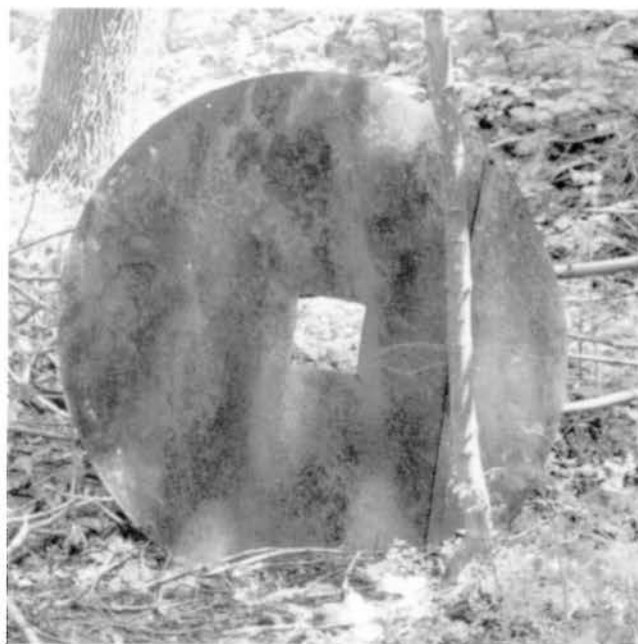
6-6. A top-loading-hole cover, unearthed at the Four Kilns site in Mount Tabor.

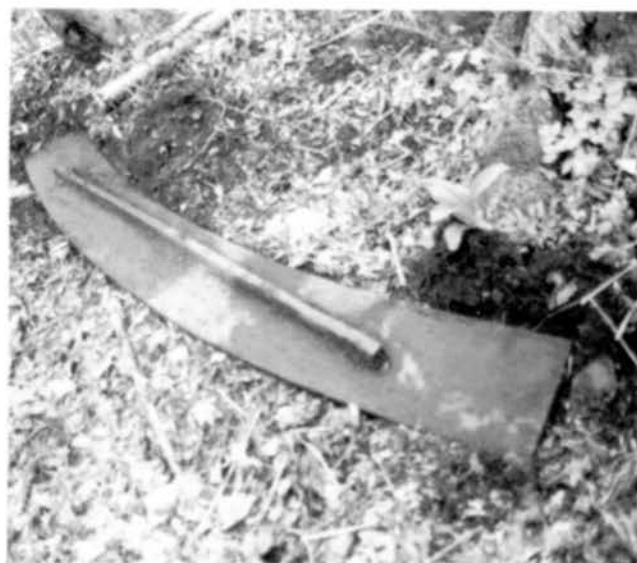
6-7. A very heavy cast-iron sill plate for a front-loading door, unearthed near the remains of a charcoal kiln at the Little Black Branch site in Mount Tabor.

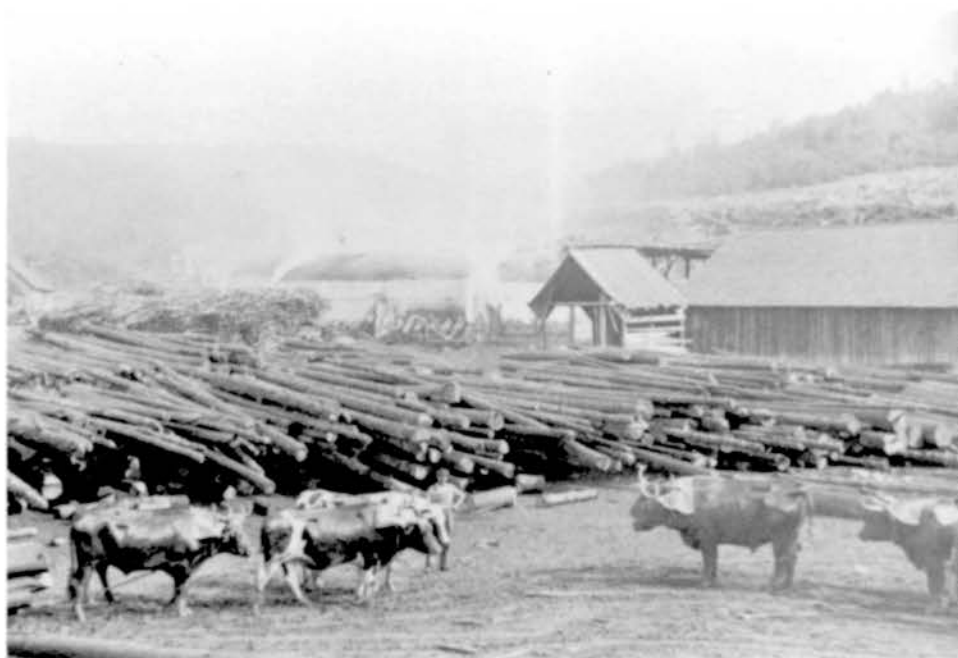
6-10. Charcoal kilns in operation at Old Job during the 1880s; note the schoolhouse at left (courtesy John Griffith, Jr.).

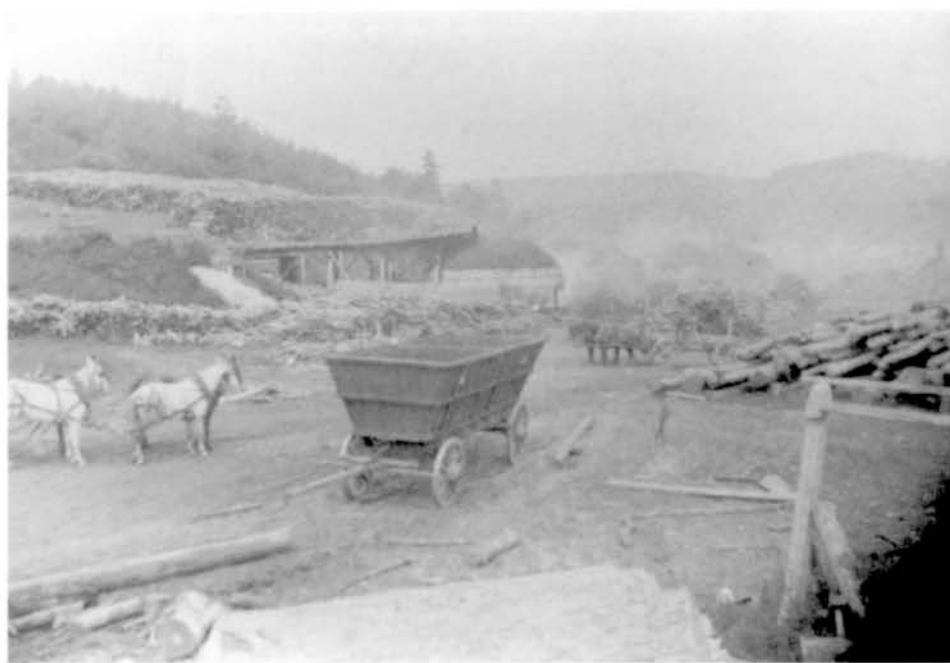
6-11. Smoke-shrouded charcoal kilns in operation at Old Job. Note cordwood on the hillside waiting to be loaded into the kilns, and a charcoal wagon in the foreground (courtesy John Griffith, Jr.).

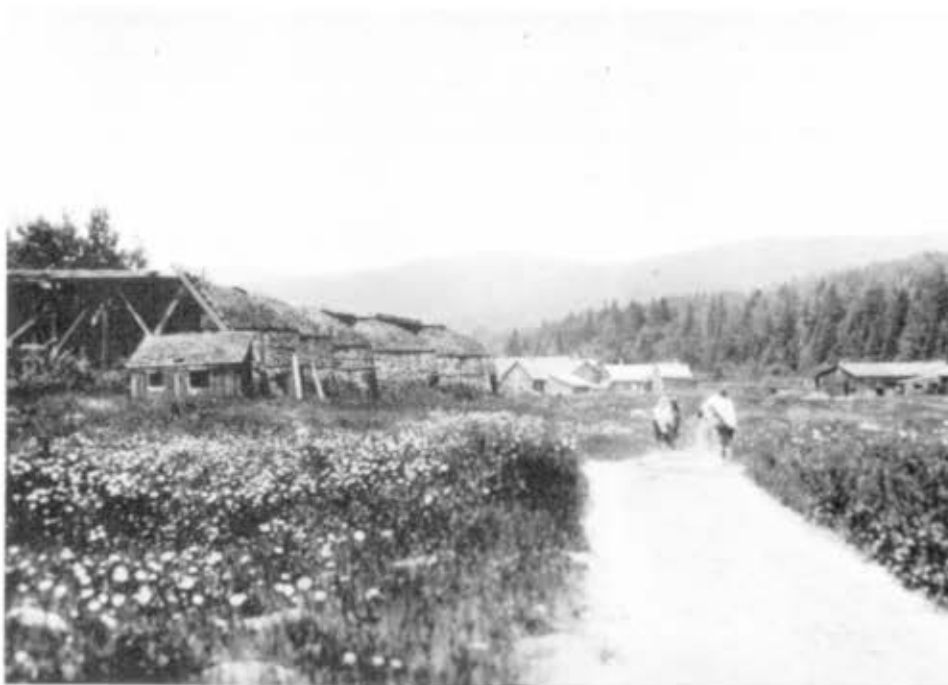
6-12. The abandoned charcoal kilns at Old Job about 1912, looking westward. Although the kilns were shut down, intermittent logging continued and the houses in the background were still occupied (courtesy UVM Special Collections Library).

6-13. It is not known for sure, but these might have been the easternmost five of the eight charcoal kilns at Old Job, determined by matching the number of iron bands in this photo with those on the kilns in figure 6-12. Notice the wicker scoop at left, used instead of iron shovels to remove charcoal from the kiln so as not to break the charcoal into small pieces (courtesy Mr. and Mrs. Karl Pfister).

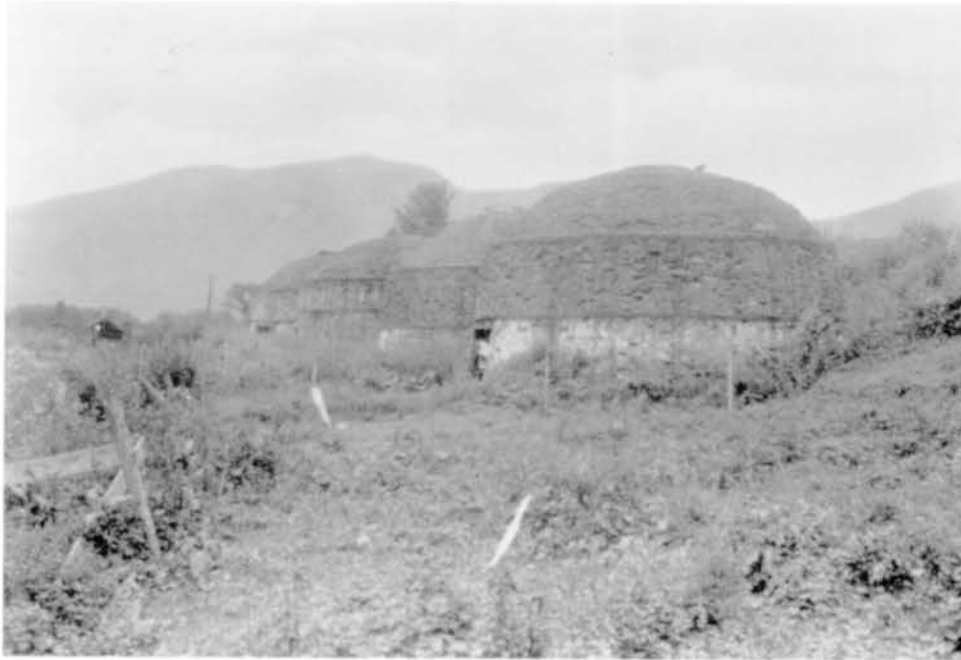
6-14. The four charcoal kilns at Danby Station as they appeared about 1950 (courtesy U.S. Forest Service, Manchester).

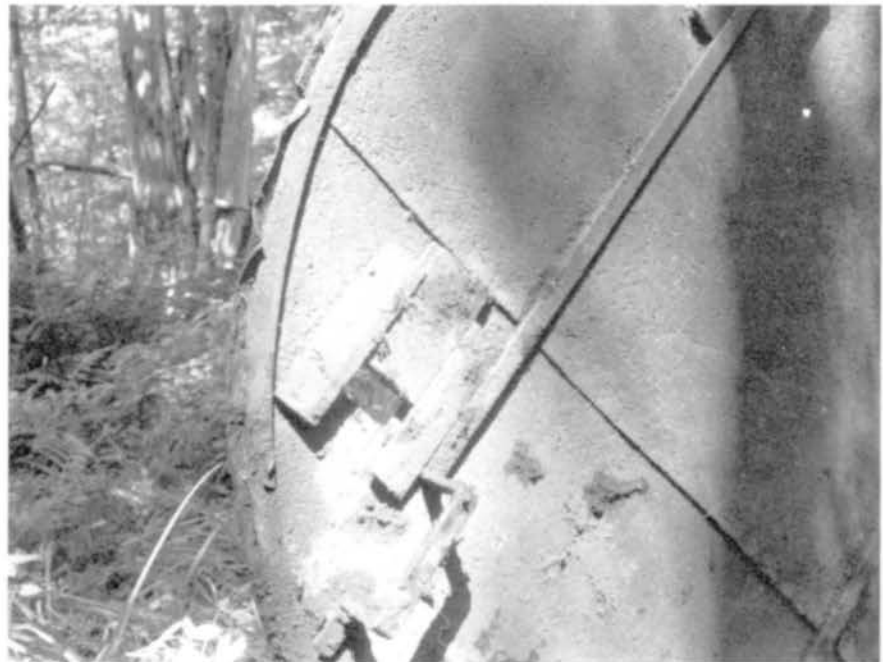
6-16. A top-loading-hole cover found near Mad Tom Brook in Peru, showing one of four vent holes with a small sliding door that controlled draft into the charcoal kiln.

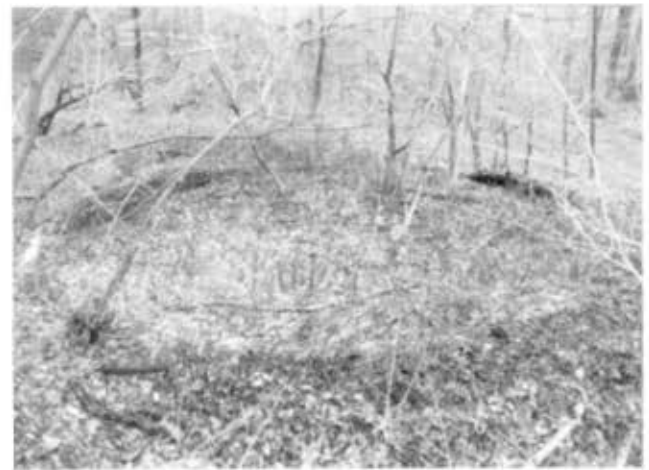
6-17. One of four brick-type charcoal kiln ruins along Long Trail at the 1,900-foot elevation, just north of Routes 11 and 30 in Winhall.

BE-43 Bromley Brook Charcoal Kilns (Winhall): Four kiln ruins lie along the Long Trail about five minutes hike north of the parking area along Routes 11 and 30, about four miles east of Manchester Depot. The ruins are in two groups of two each, about 30 feet apart a dozen feet south of the trail. They were found in 1982 with the guidance of Sandy Partridge of Proctor. The ruins are not difficult to find since the trail here is black with charcoal runoff from the ruins.

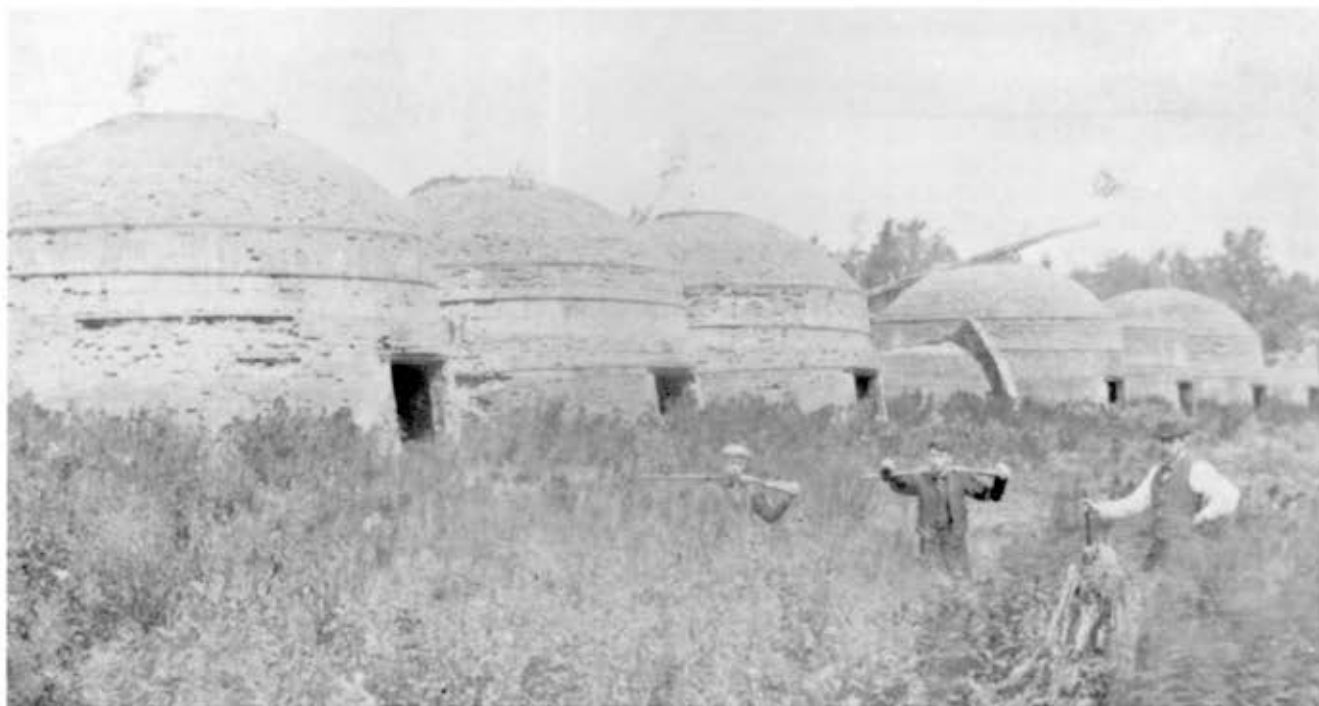
6-18. The eight charcoal kilns near Bourn Brook in 1893, a few years after they ceased operation and became overgrown with brush. Note that two kilns, in the middle and rear, had already collapsed (courtesy Mr. and Mrs. Daly Rizio).

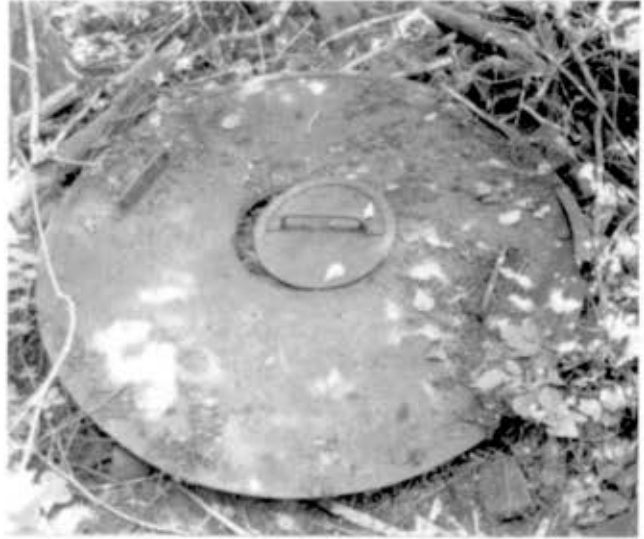
6-20. A top-loading-hole cover with another smaller, removable cover, found at the Bourn Brook site.

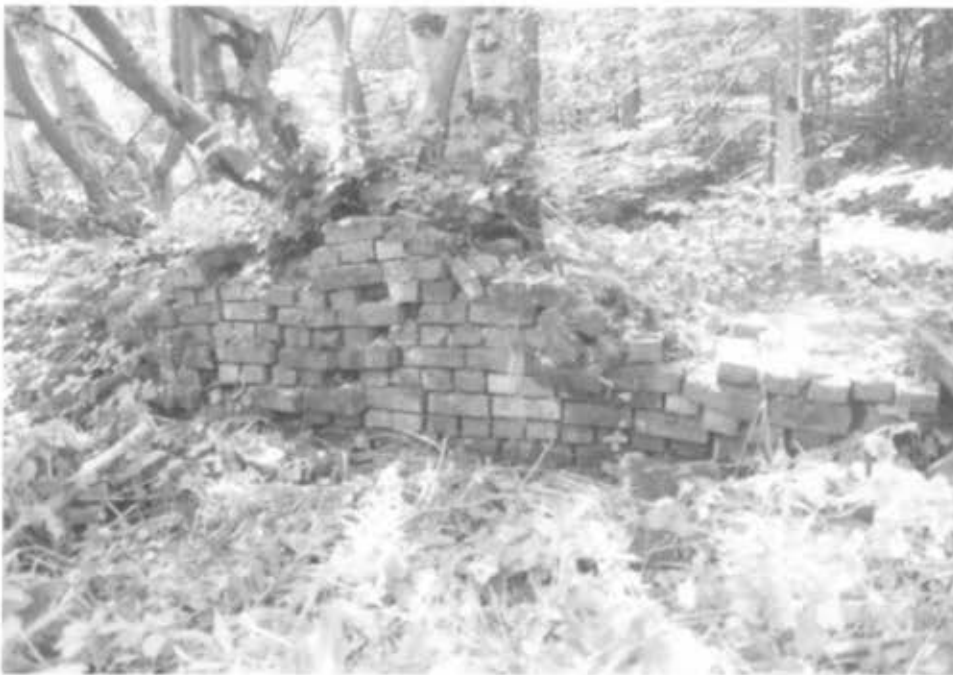
6-19. Ruins of one of the eight charcoal kilns in figure 6-18 in the 1980s. Nearby is the abandoned logging village of Rootville.

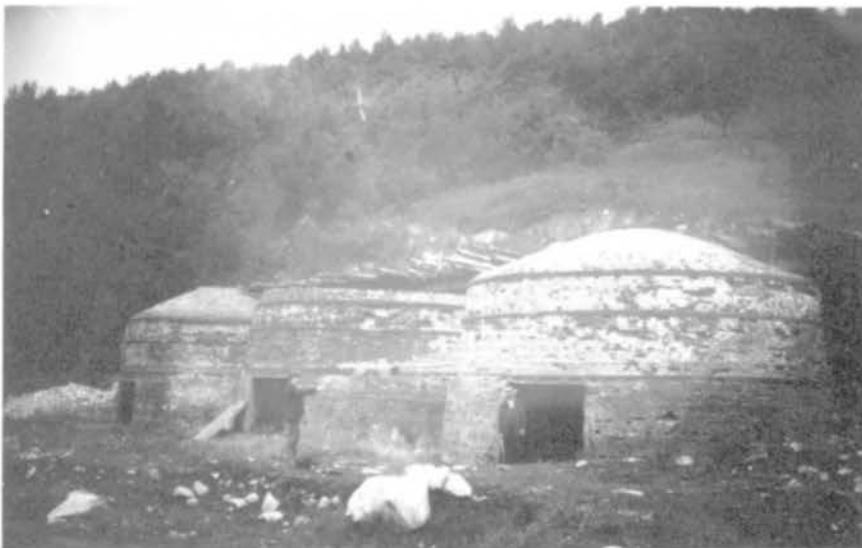
6-22. Charcoal kilns up the west draw at "the forks" in Glastenbury. Only circles of brick remain at this site today (courtesy Tordis Isselhardt).

Five more charcoal kiln ruins (BE-47) were found about a half-mile up the west fork later the same day. The ruins are immediately downhill of the road leading up the west fork of Bolles Brook. The ruins appear in much the same condition

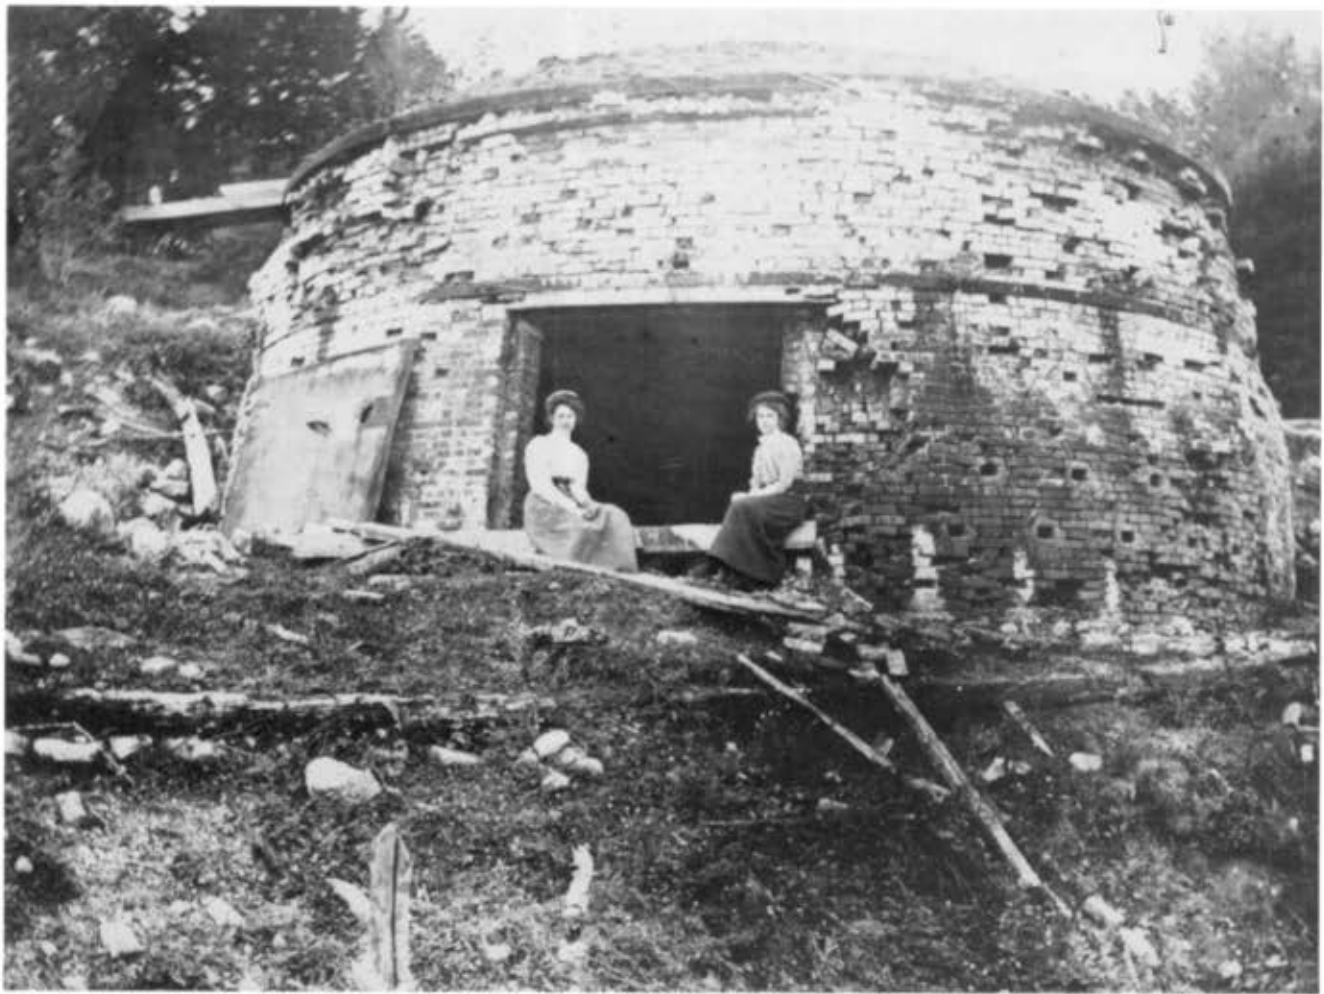
6-23. Vacationers visiting a long-abandoned charcoal kiln up Bolles Brook in the Glastenbury-Woodford area sometime before World War I (Lester B. Nichols photo; courtesy Bennington Banner).

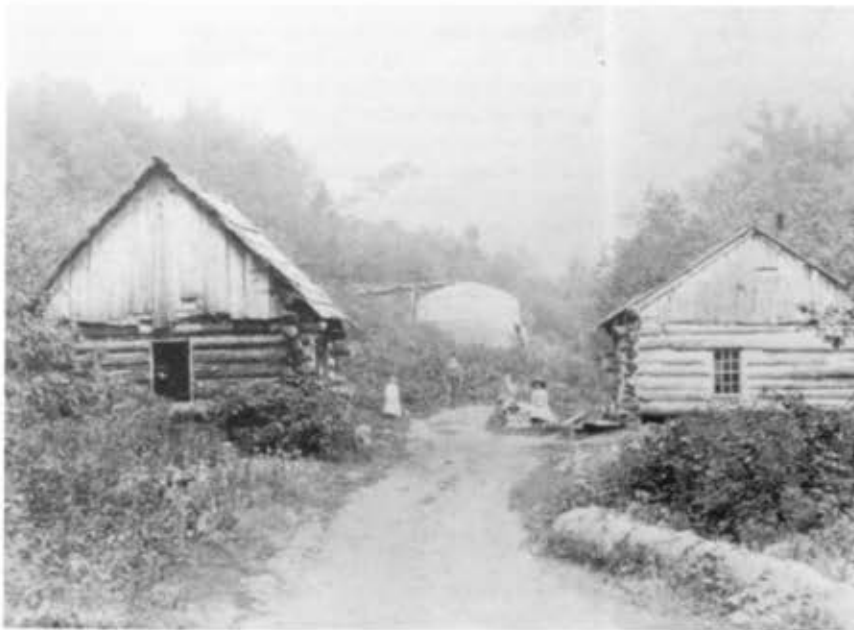
6-24. A ca.-1900 view of a charcoal kiln and collier's house (?) reportedly in Woodford. This might have been one of the three single-kiln ruins found up Bickford Hollow in 1983 (courtesy Bill Gove).

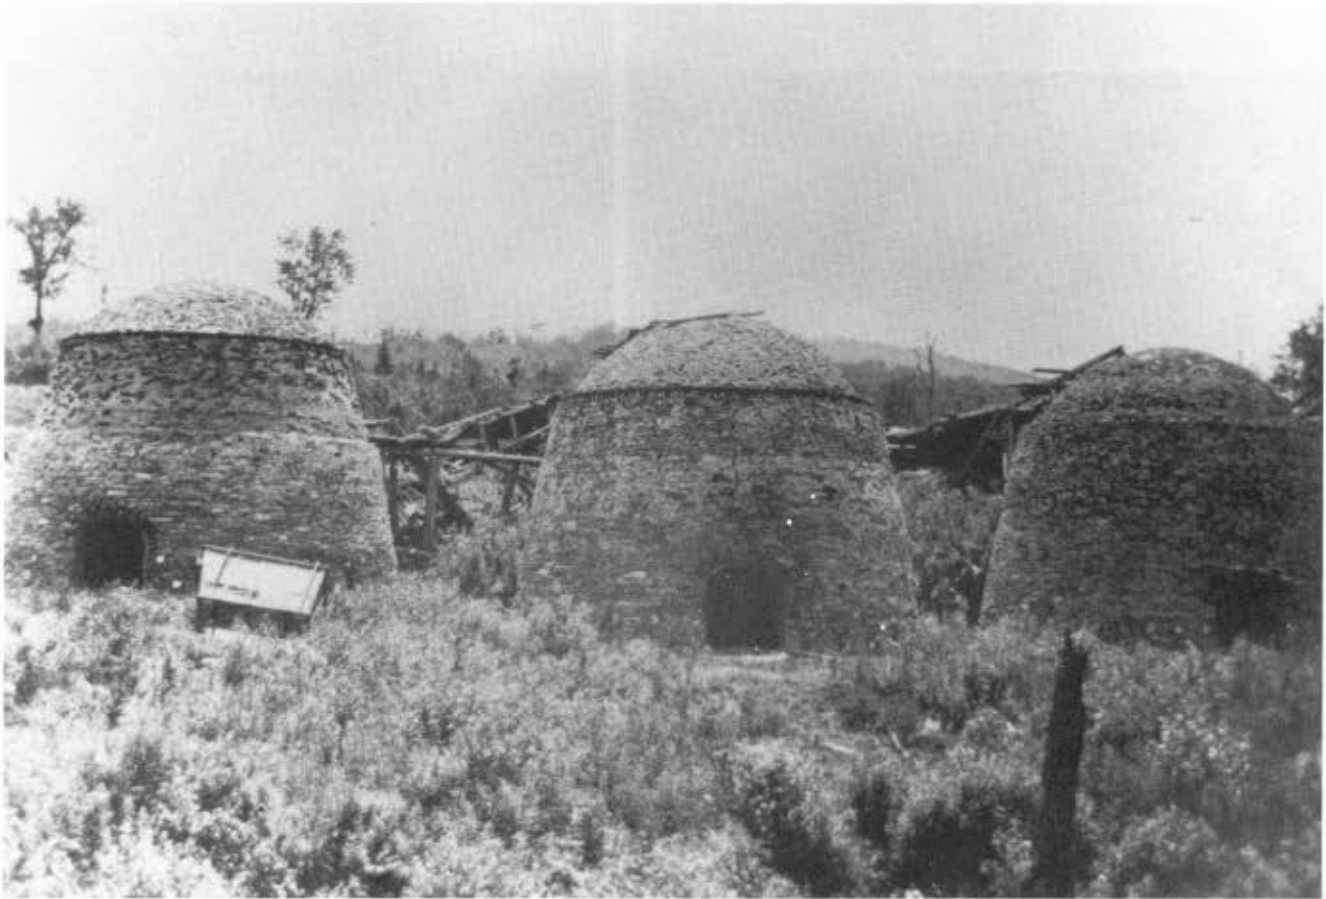
6-25. Three of the four charcoal kilns north of Old County Road in Stamford, photographed near the turn of the century and about 50 years after the kilns had gone out of business. Notice tipped-over charcoal cart at left (courtesy Eugene Farley, Andrew C. Rumgay, and The Transcript, North Adams, Mass.).

The four stone-type ruins were in fair to good condition, ranging from fully collapsed to having walls up to 8 feet high, and stand in a row a dozen feet downstream from the Roaring Branch trail crossing. Mortar and cement were used to seal the walls and bricks to control the vents. Additionally, the inside walls were coated with as much as an inch-thick layer of burnt pitch, which must have aided in keeping the kiln walls airtight. The main kiln openings faced on the brook. Hardware found

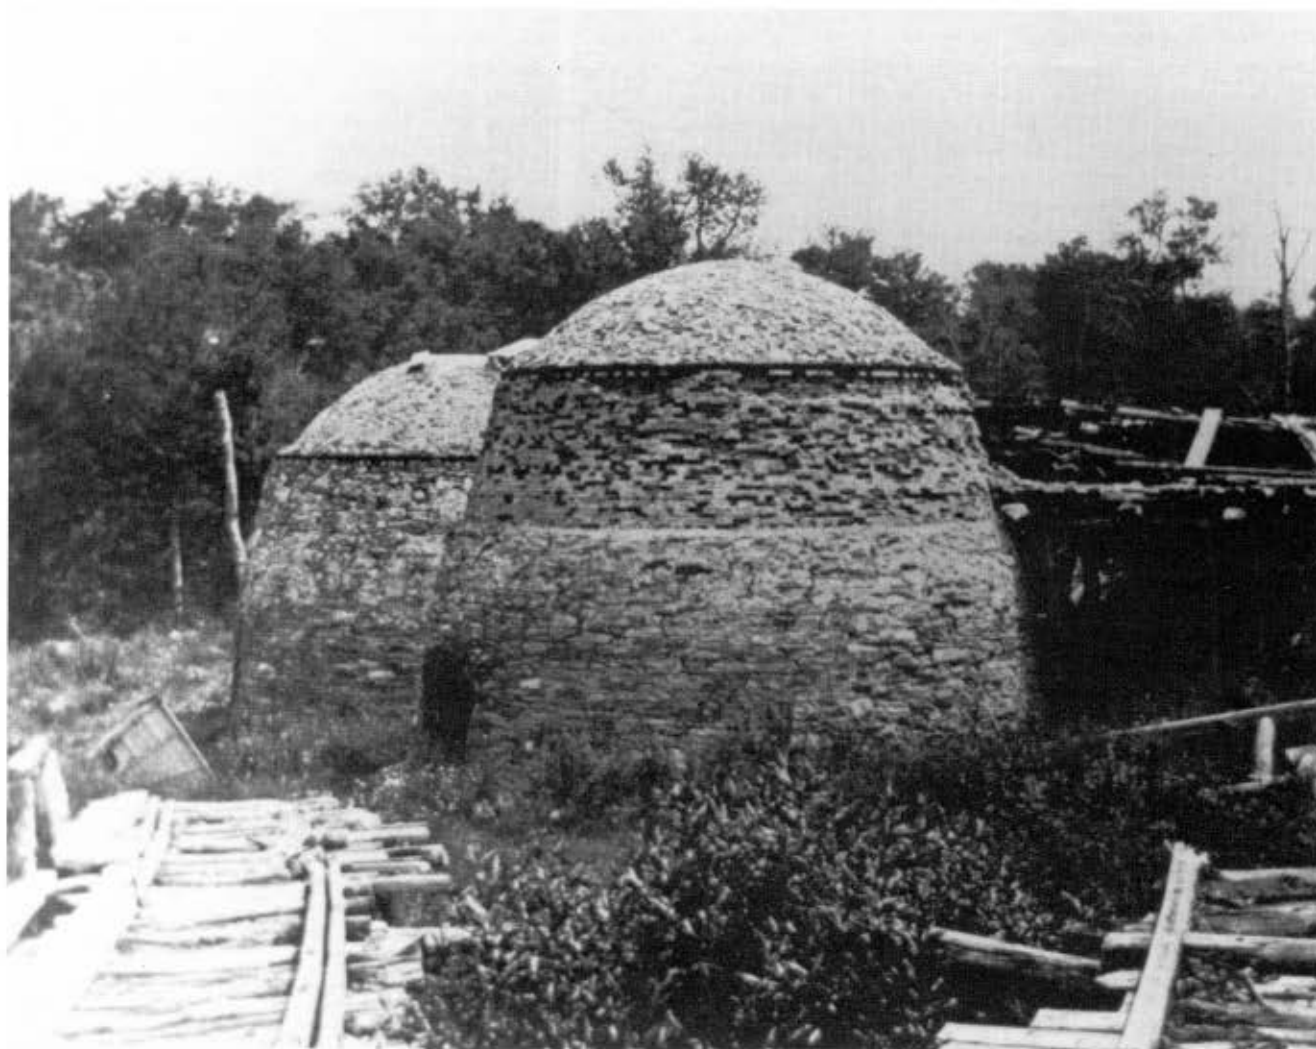
6-26. Another view of the charcoal kilns north of Old County Road, showing wood tracks on which the charcoal cart ran (courtesy Eugene Farley, Andrew C. Rungay, and *The Transcript*, North Adams, Mass.).

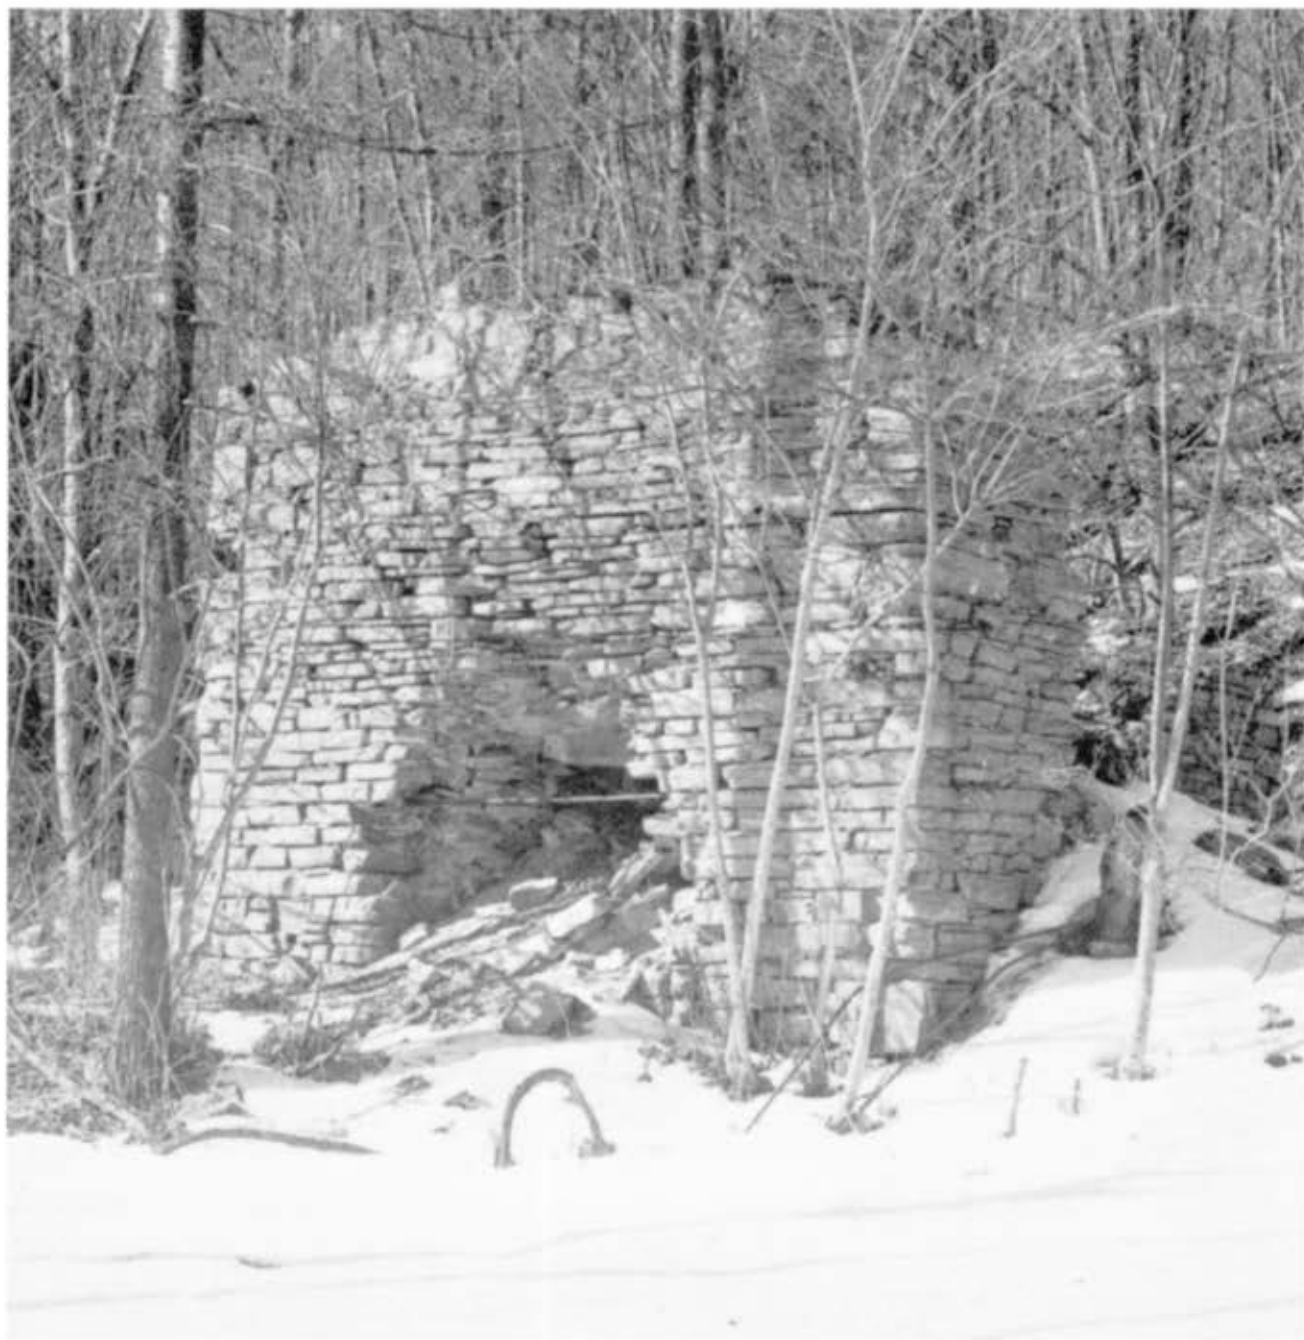
A partially standing lime kiln ruin near Cavendish Station, showing advanced breakdown of the front arch and the iron binding holding together what remains.
