Chapter 8 Study of Lime Kilns

Results of the Lime Kiln Study

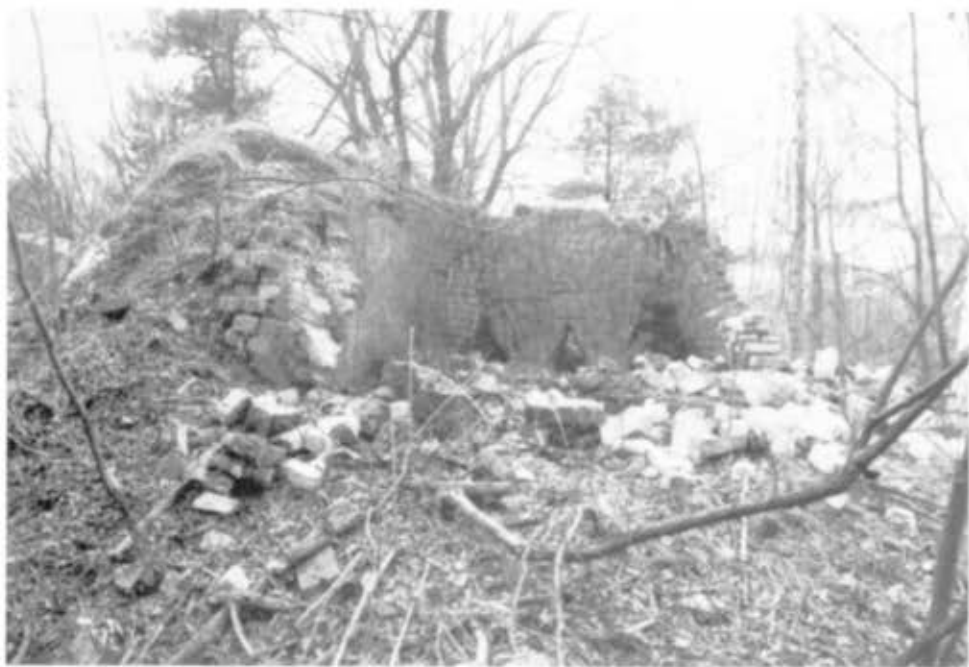
8-2. Inside one of seven lime kiln ruins of the Missisquoi Lime Works at Highgate, showing firebrick lining and multiple arches for draft.

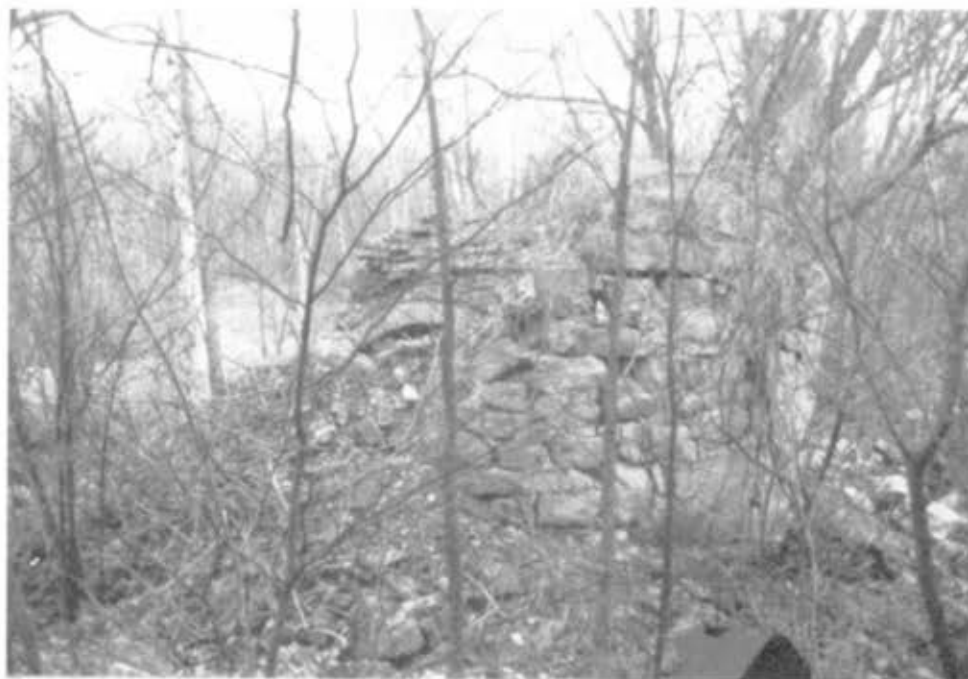
8-3. The opposite side of the wall shown in figure 8-2, showing the brick arch, through which draft was drawn into the kiln.

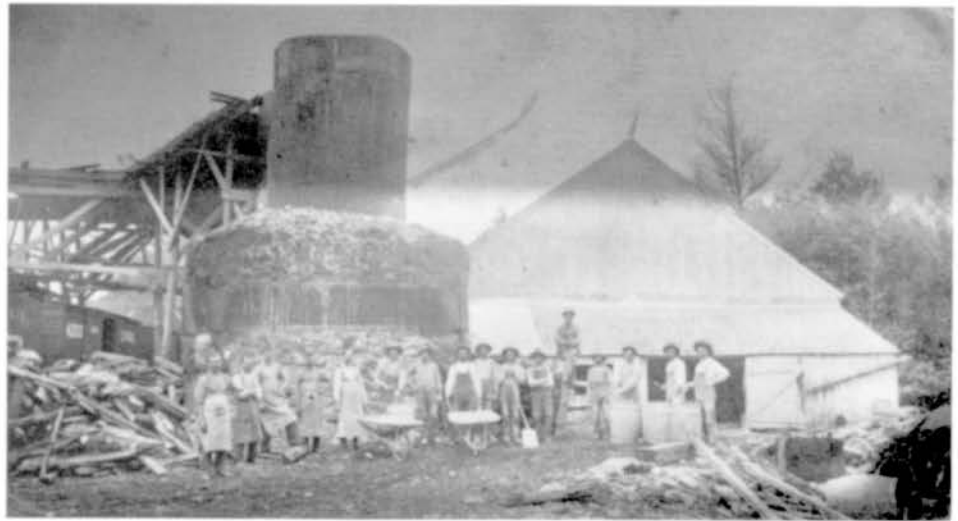
8-4. Workers gather around the lime kiln for the photographer in this ca.-1900 photo. Note the railroad cars under scaffolding at left, possibly indicating this kiln is either at Fonda or beside the spur track at Highgate Springs. The wheelbarrow was used for carrying the burned lime from the kilns to the barrels (courtesy Bob Douglas).

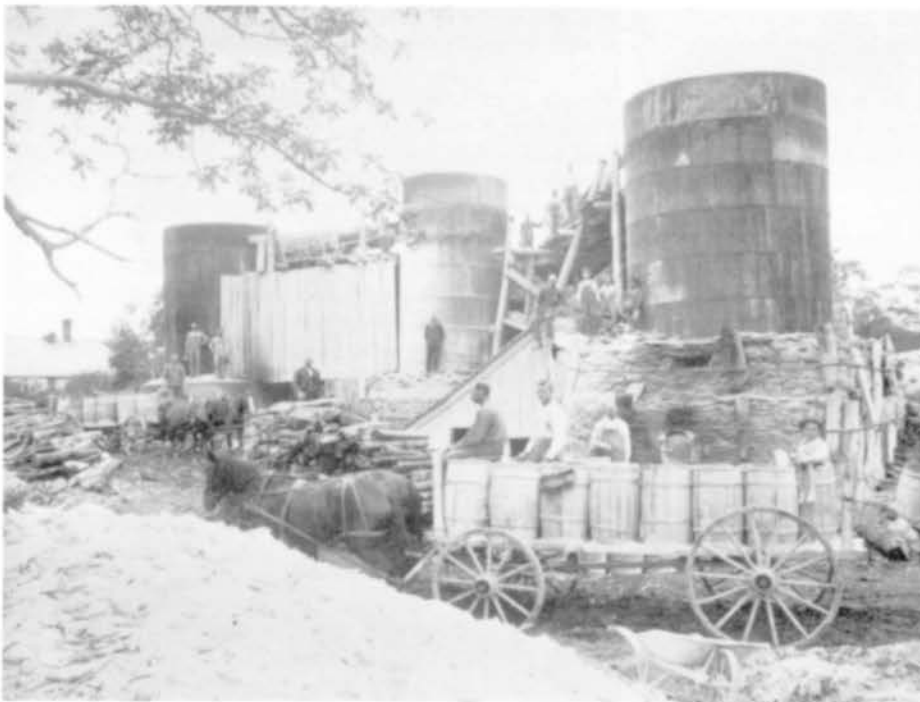
8-5. Another early view of lime kilns in Swanton or Highgate, showing horse and wagon atop wood scaffolding between two kilns at left, small door and iron binding around kiln at right, and young boys standing beside the stack. The wagon carried off the burned lime in barrels.

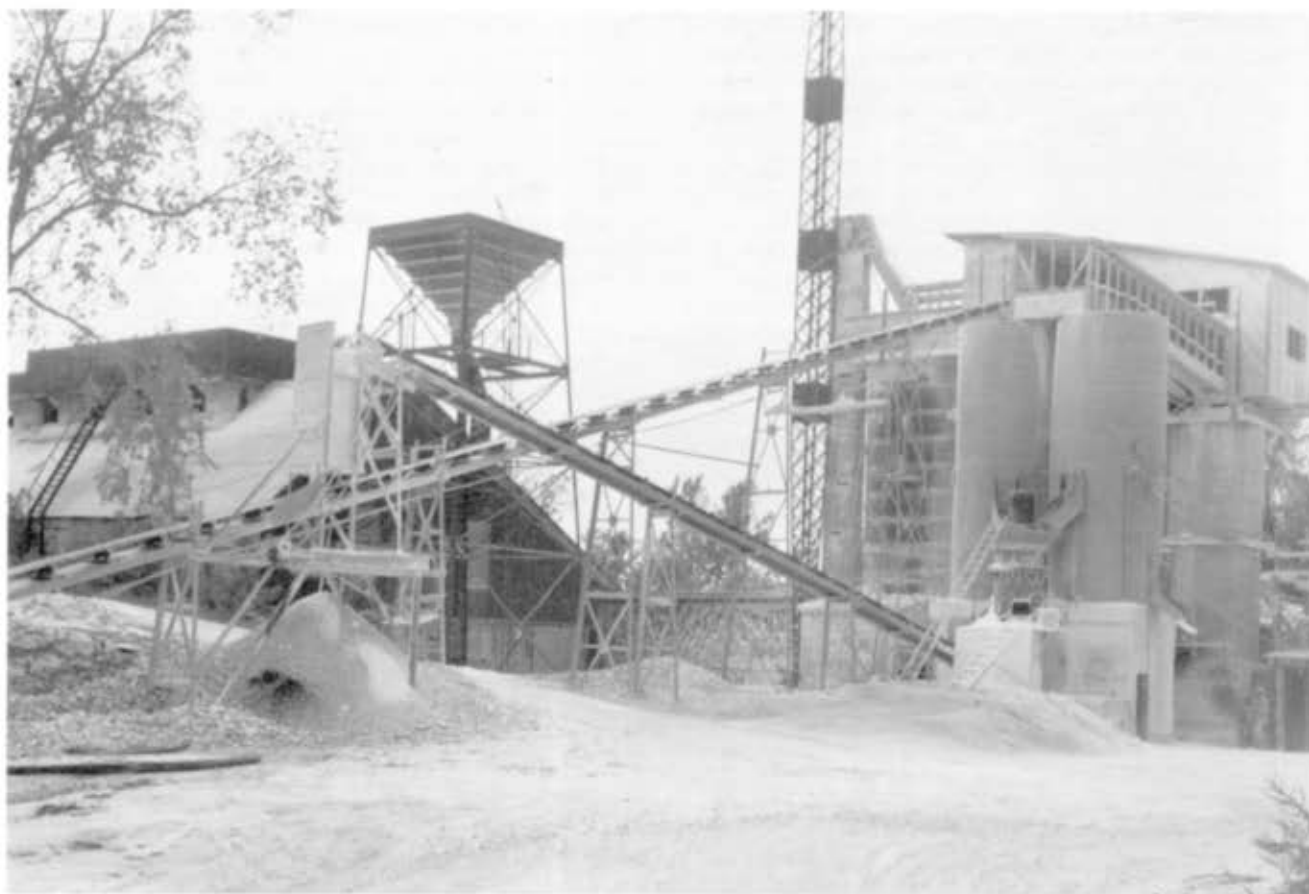
8-7. The Swanton Lime Works lime kiln shed at left housed five kilns, as seen by their tops visible through the roof. These kilns operated from the early 1900s to about the 1970s (courtesy Bob Douglas).

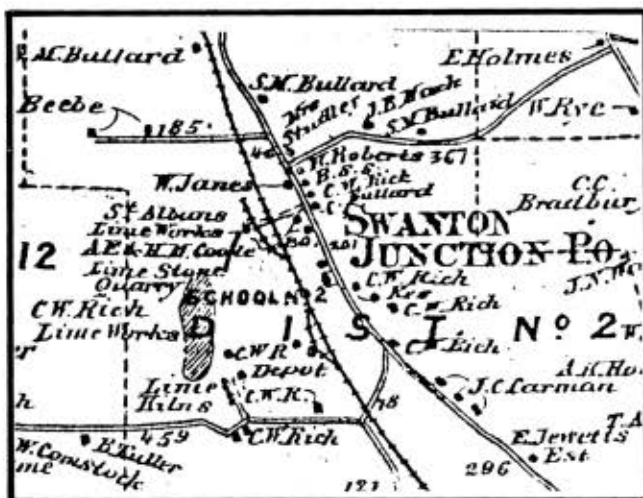
8-9. Lime operations at Fonda (Swanton Junction) in 1871, showing (north to south) the "St. Albans Lime Works," the "C. W. Rich Lime Works," and "Lime Kilns" west of the railroad tracks and surrounding the limestone quarry (Beers Franklin 1871:14).

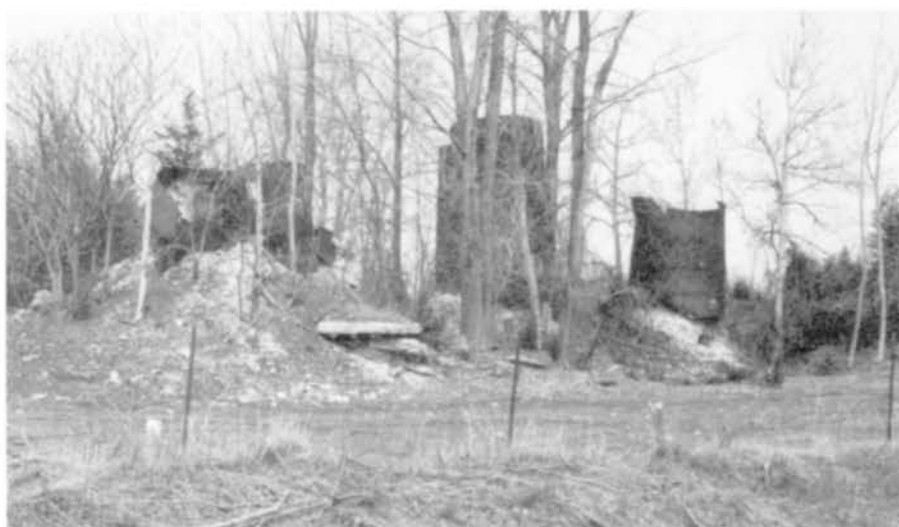
8-12. A 1986 view of kiln ruins at Fonda, showing disposition of their crumbling stone bases and rusted iron shells.

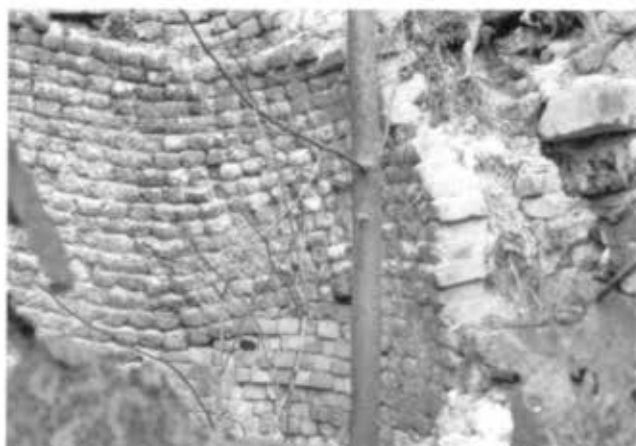
8-13. Firebrick lining inside one of the kiln ruins at Fonda.

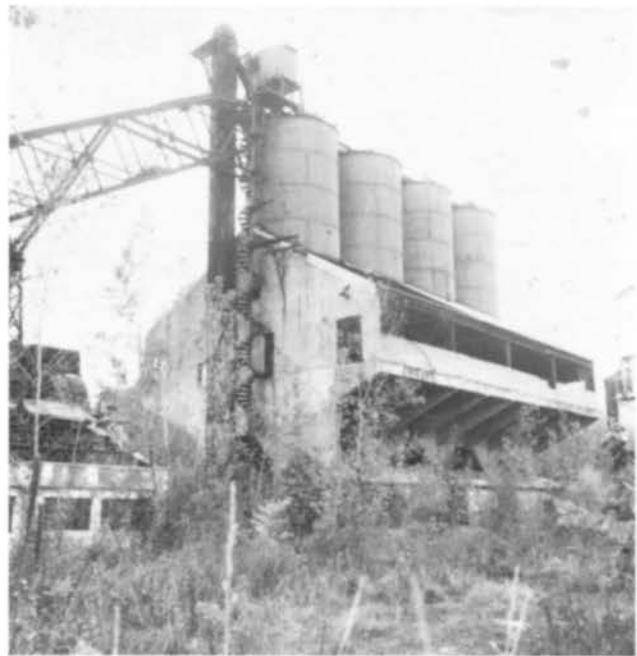
8-14. Lime kilns at Winooski Park just before the site was razed in 1990 for scrap metal. Limestone was raised from the quarry, at left, to the top of the kilns via a skip car.

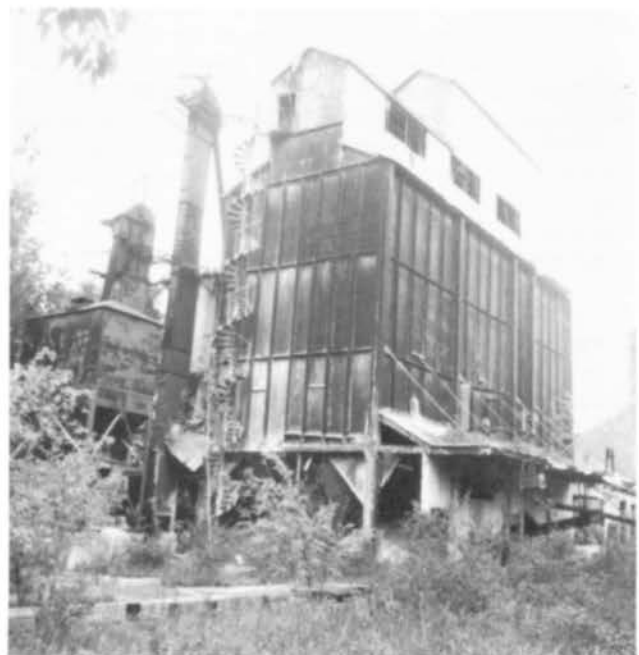
8-15. From the kilns shown in figure 8-14, lime was crushed and ground into a fine powder by machinery in this building, located just south of the kiln building (background). Only the foundation remains of this structure today.

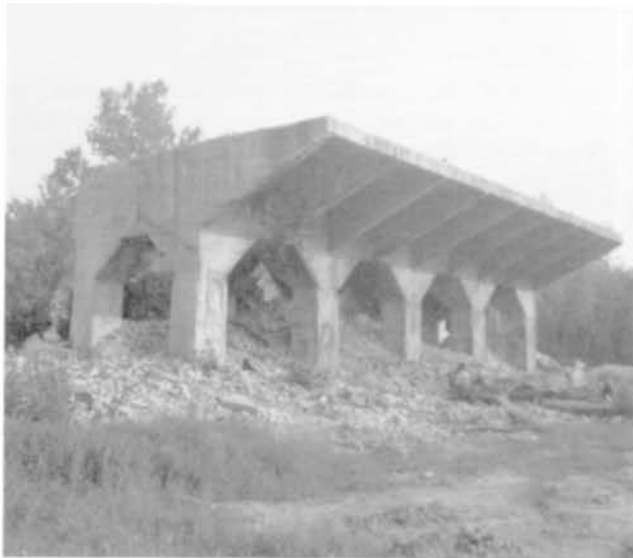
8-16. Remains of the lime kiln building at Winooski Park after the site was stripped for scrap iron.

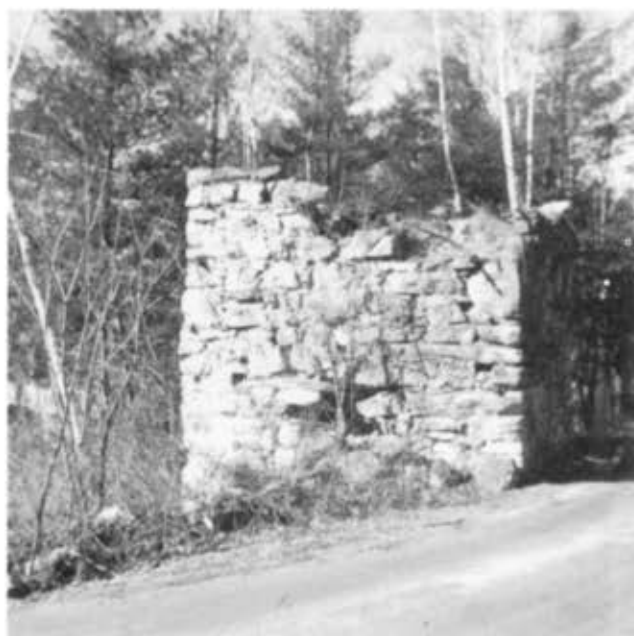
8-18. A magnificent lime kiln ruin at the end of a private driveway just west of Bristol village.

face plates snug to the stone walls with beveled iron pins inserted into the slots, keeping the face plates, and thus the stone walls, from shifting outward. This type of iron binding, face plate, and beveled pin is similar to that found on blast furnaces at Troy, Pittsford, and Forest Dale.

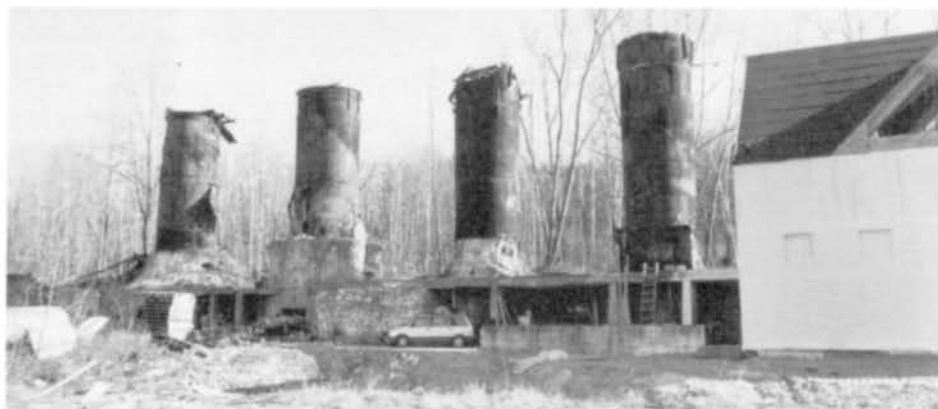
8-19. Spectacular ruins of four lime kilns just east of New Haven Junction. The base of the fifth kiln is at the left.

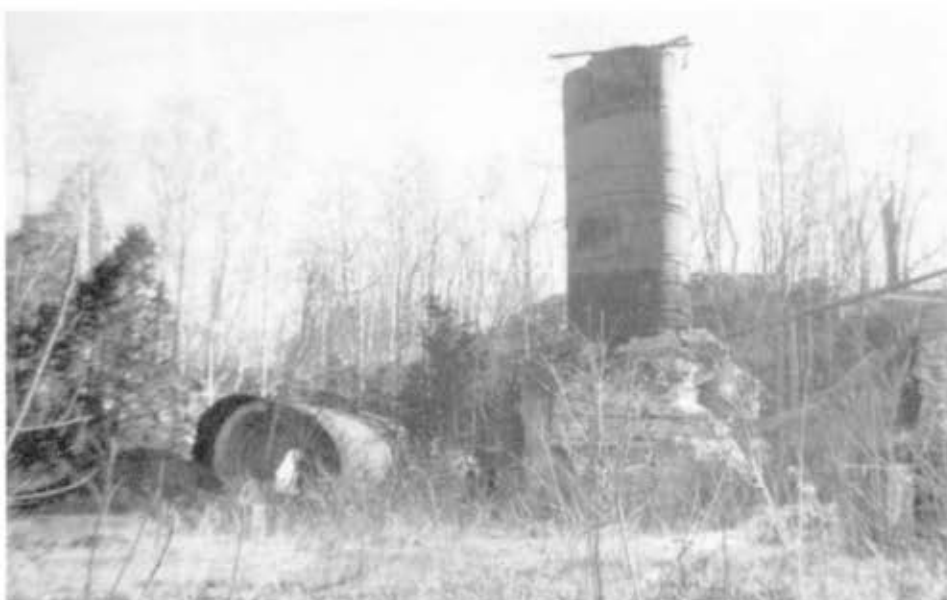
8-24. Lime kiln ruin at Leicester Junction, which operated in the 1850s to the 1930s.

In 1918 the operations were owned by Harry B. Huntley and the quarry had grown to 450 feet long, 125 feet wide, and 75 feet deep. The two kilns were fueled by wood and had a daily capacity of 10 tons each. Burned lime was used mainly for chemical purposes but the finer quality went for fertilizer. Price was \$11.00 per ton and \$2.00 per barrel (Jacobs 1918:163).

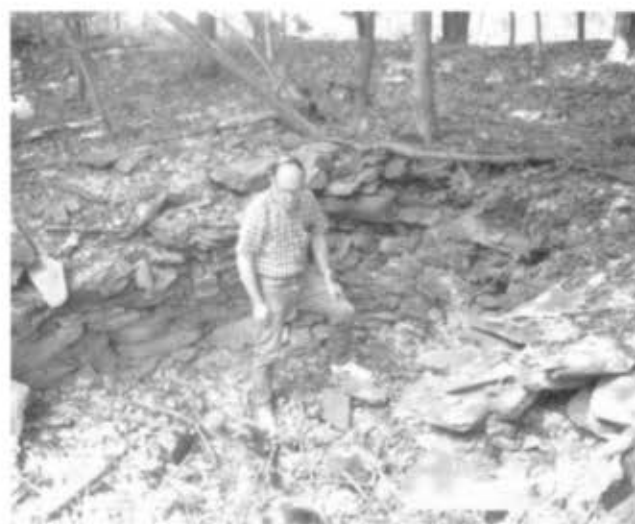
8-25. Scotch Hill lime kiln ruin, found alongside the road amid slate tailings.

RU-98 Scotch Hill Lime Kiln (Fair Haven): This ruin is five miles north of Fair Haven, next to a slate quarry on the west side of Scotch Hill Road. The Fair Haven history mentions a "lime kiln quarry" that operated near the town line toward West Castleton (Adams 1870:214). But it is unknown for sure whether this or another quarry is the object of the statement since there are many quarries in that area and many of the referenced names are associated with more than one slate quarry.

The kiln ruin was initially found in 1985 as part of a search for charcoal kilns that are indicated in the 1869 Beers maps of Fair Haven and Castleton (the charcoal kiln ruins were not found). No limestone quarry could be found in the area of the ruin. Might slate-quarrying activity in the vicinity during the ensuing 100 years have excavated and/or buried it?

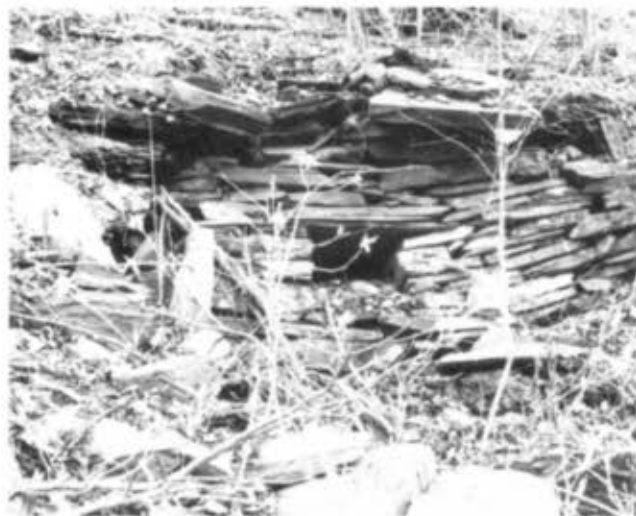
8-26. Lime kiln ruin at Fair Haven, made of some of the abundant slate in the vicinity.

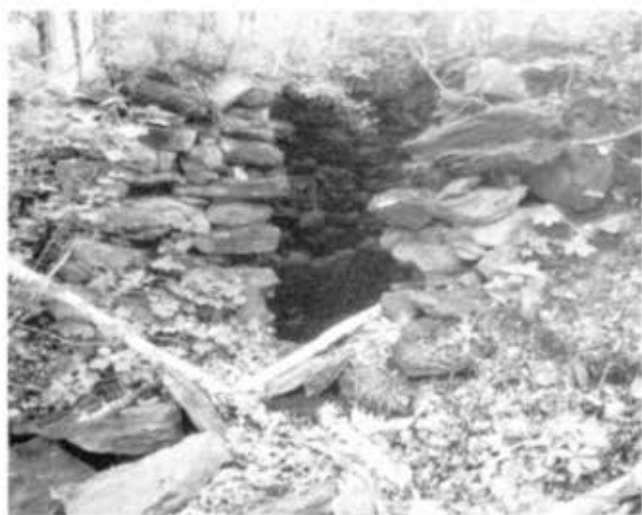
8-27. A lime kiln ruin in a pasture at the Maplebrook Farm in Tinnmouth. The front wall was opened several years ago to rescue a cow, which had fallen through the hole at the top of the kiln.

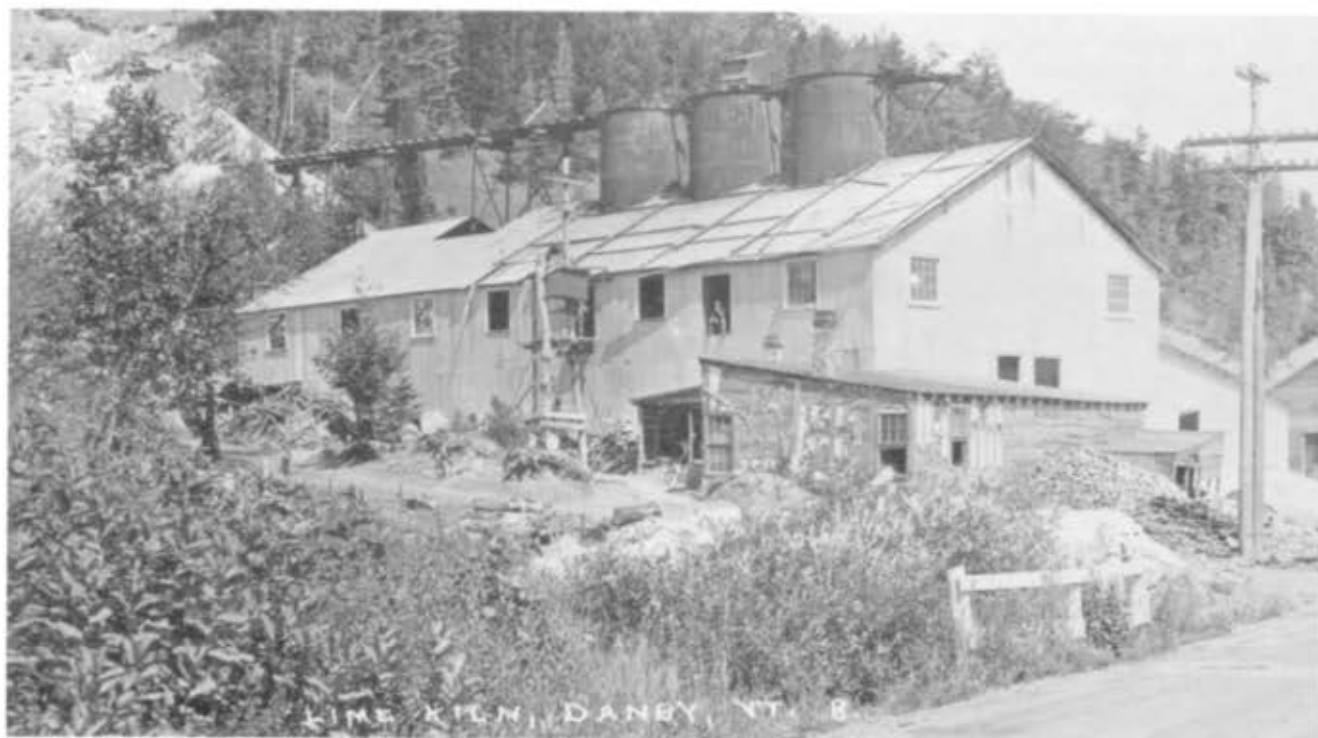
8-28. The Vermont Lime Products Corporation at Mount Tabor in this 1920s–1930s view. Note rail car above middle kiln. Road at right is today's Route 7 (courtesy Vermont Historical Society).

was opened and the kilns and buildings were erected on the west side of Route 7. The office was on the east side of the highway. There was a railroad siding from the Rutland Railroad across the highway to the storage buildings. The business consisted of the quarrying of limestone and manufacturing of lime products. This operation was carried on until the early 1930s. In 1949, the town of Mt. Tabor took the property over for delinquent taxes (Crosby et al. 1976:45).

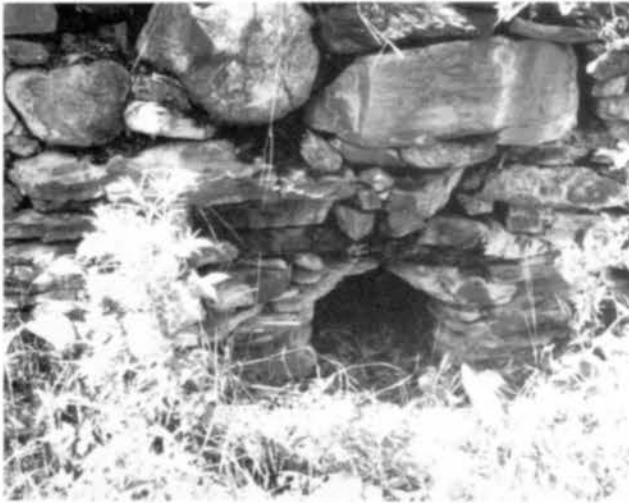
8-30. Bottom opening of the Knapp kiln ruin near Woodward Reservoir at Plymouth.

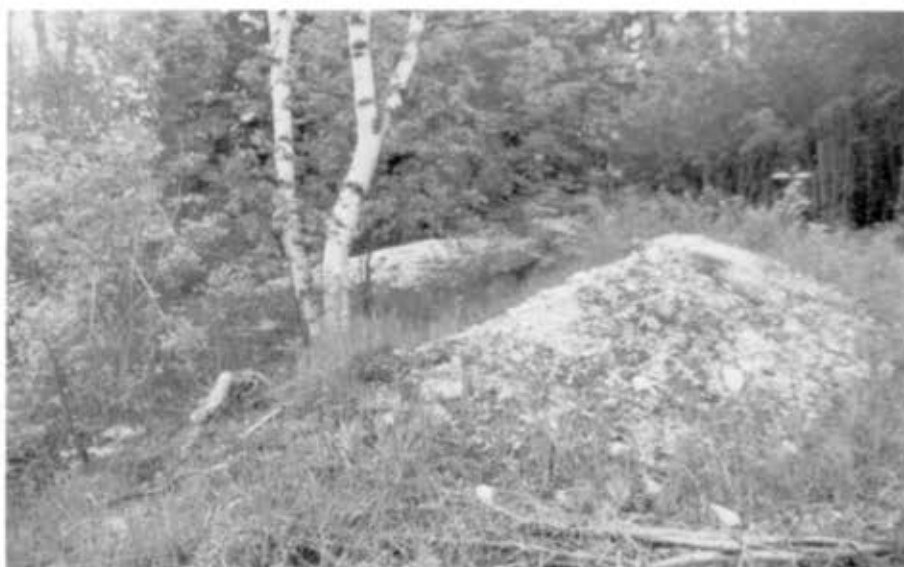
8-31. Other than the lime kiln ruin itself (this one at Plymouth Notch), its most visible indication was the burned lime residue that was sometimes noticed before the actual ruin was found. Yellow birch and white birch were also found in association with many lime kiln and charcoal kiln ruins.

feet north of the stone house, both on the west side of the road. The kiln ruin is about 30 feet from the road in an open section of land, very obvious to anyone driving or walking along the road. High voltage wires pass just over and between the ruin and the road.

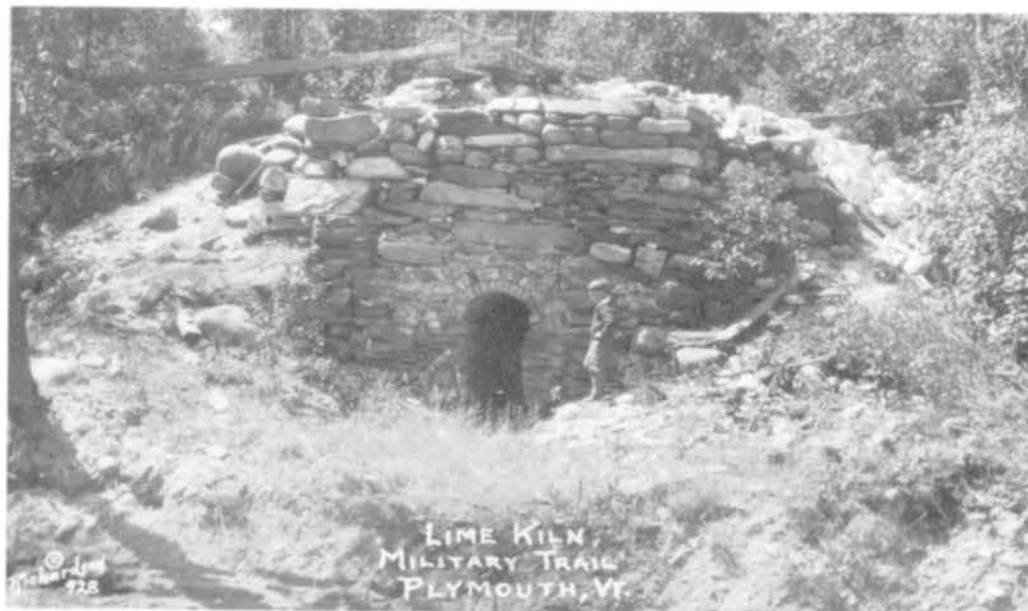
8-32. The Rice lime kiln at an earlier time, showing the decorative brick arch which is missing today.

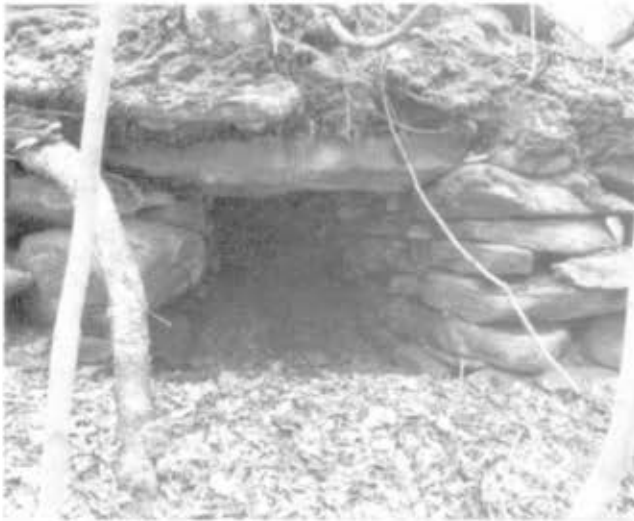
8-34. Partly hidden by tree roots, this primitive-looking lime kiln is one of a pair built into a common structure, just west of Downers.

Both kiln openings are roofed by single lintel stones; the eastern unit lintel is broken but the western unit stone is intact. These flat stone lintels with their stone side supports look much like various stone chambers found elsewhere in Vermont (Neudorfer 1980:16). Some wood beams appear in part of the ruin, hinting at possible structures once associated near or on

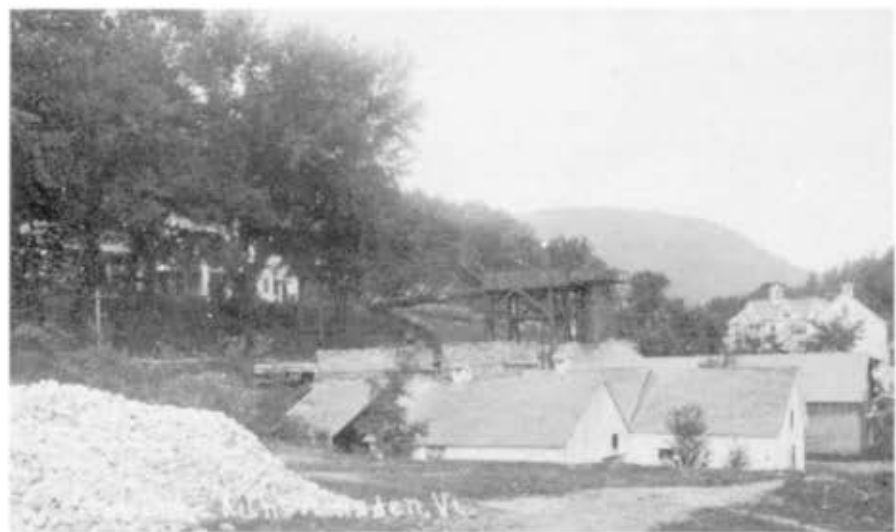
8-35. Ca.-1920s view of lime kilns at Amsden, showing tall iron shell above kiln in background. Whether the two foreground units were in operation at this time is unknown (courtesy Edith Hunter).

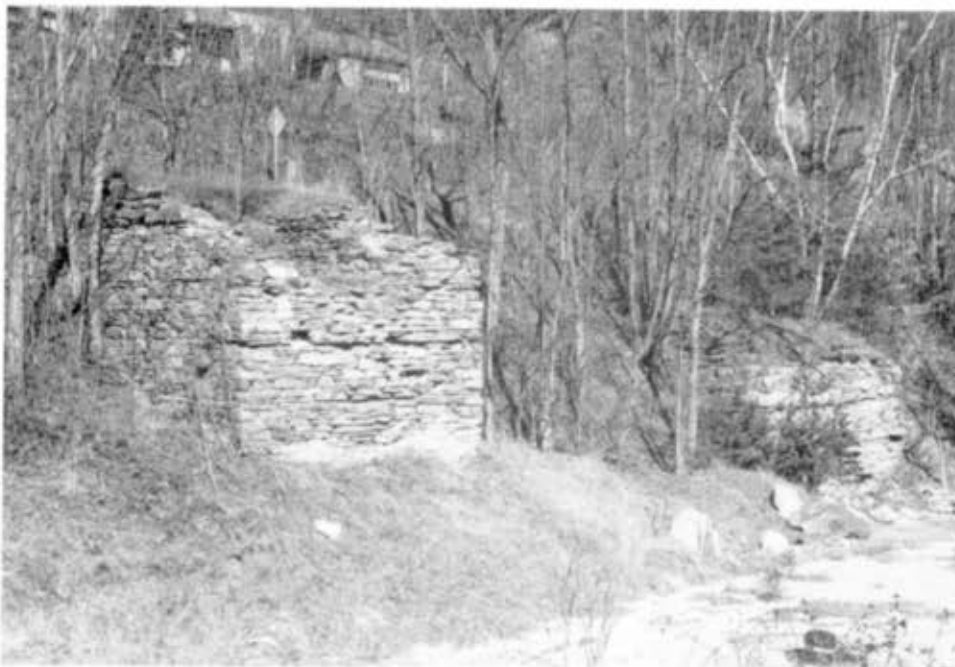
8-37. The two surviving lime kiln ruins at Amsden in the spring of 1991.

the kiln to a charging ramp and bridge that ran up to the top of the kiln from the embankment above and west of the highway. No charging ramps can be seen leading to the tops of the two stone kilns.

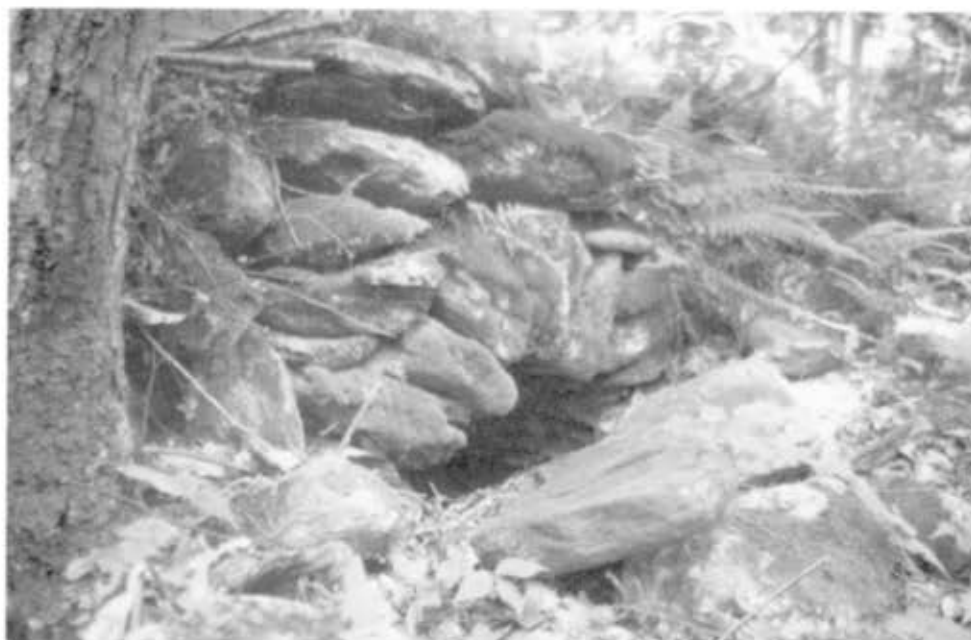
8-39. Collapsed ruin of a small lime kiln near North Dorset showing section of the front archway.

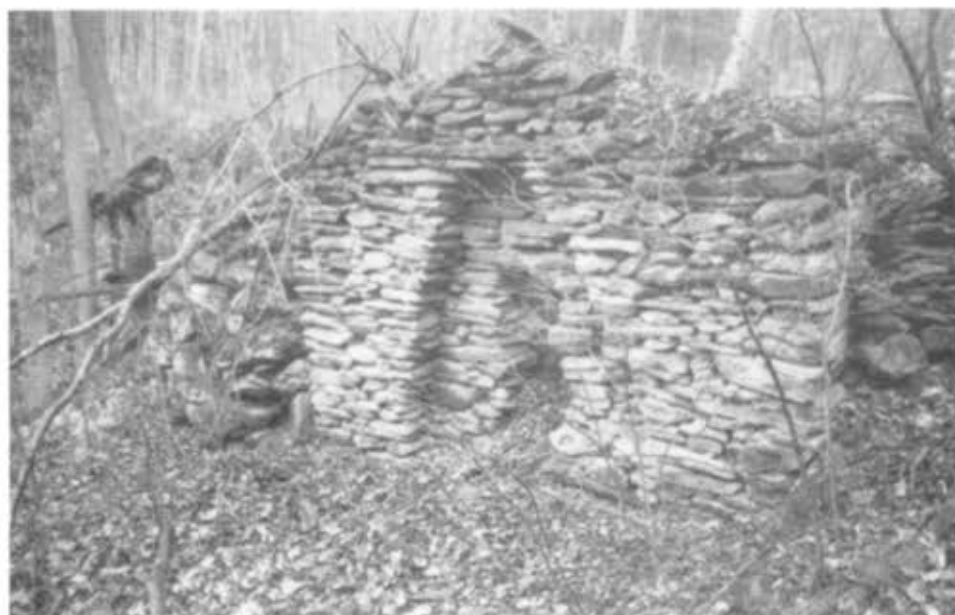
8-40. *The graceful ruin of the Thayer lime kiln at Jamaica, showing the decorative Gothic arch and front portal.*

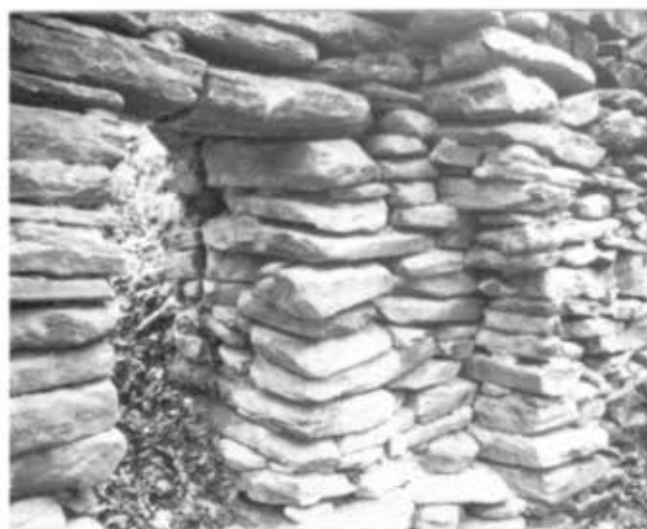
8-41. *Close-up view of the front opening of the Thayer kiln. Note cracked lintel stone still holding up the heavy stonework above; early Vermonters built well.*
