# Sloop Island Canal Boat: A Preliminary Report on the Phase III Study of an Early-Twentieth-Century Canal Boat Wreck

by Scott A. McLaughlin and Adam I. Kane

This vessel, known by researchers as the Sloop Island Canal Boat (VT-CH-843), was the focus of a Phase III mitigation undertaken by the Lake Champlain Maritime Museum

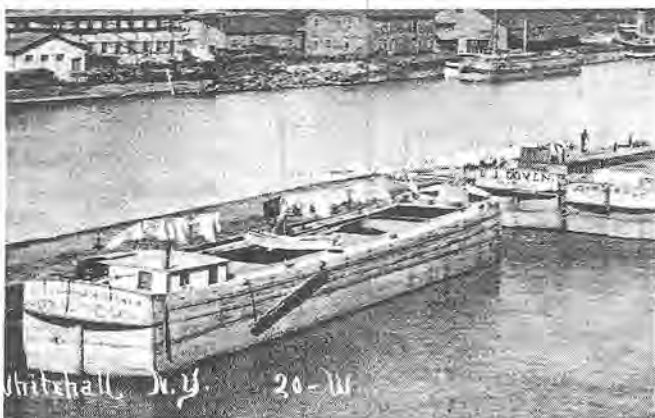
Figure 5. Canal boats docked at Whitehall, New York, on Lake Champlain, circa 1910s (courtesy of the New York State Archives).

The Champlain Canal's second enlargement began after a flurry of suggestions by politicians, boatmen, and shippers, all urging New York State to build the Champlain Canal to at least the dimensions of the Erie Canal. Some even encouraged an expansion sufficient to handle sea-going vessels. In 1864, New York resolved to enlarge the Champlain Canal to the same dimensions as the Erie Canal. The new locks, completed in 1873, measured at least 110 feet long and 18 feet wide. The enlargement of the canal prism, however, was not completed until 1877 with the dimensions of at least 65 feet at the water's surface and containing a minimum water depth of 6 feet. This fell short of the Erie Canal's dimensions by 5 feet in width and 1 foot in depth. Canal boats now averaged 97 feet long and 17½ feet wide; the Sloop Island Canal Boat belongs to this class (Figure 5).

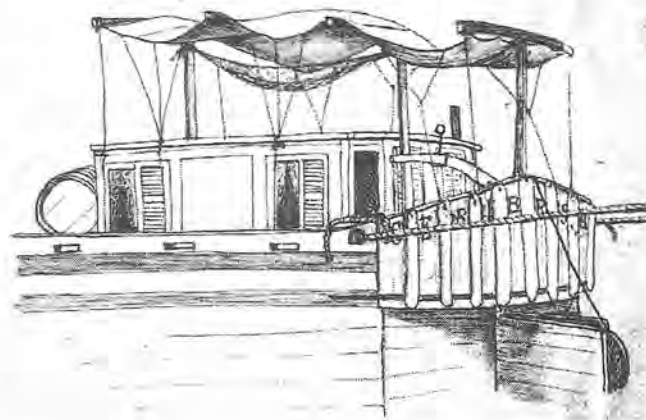
Figure 9. Stern of canal boat *George Brush*, 1895, drawn by *Augusta W. Brown* (courtesy of the New York State Museum).

An awning frame was placed above the cabin roof on which a canvas tarp was stretched to keep the cabin cooler (Figure 9). This provided a place to sling a hammock for sleeping and places for rocking chairs in which to rest, read, do handiwork, or gossip with the neighbors in the tow. Decks of canal boats made for a restricted and dangerous place to play, so the cabin roof also became a playground for the canal family. Toddlers were hitched into a leather harness and connected to a rope that allowed them the freedom to run around the cabin roof, but not fall off into the water (Godfrey 1994:87; Springer and Hahn 1977:36).

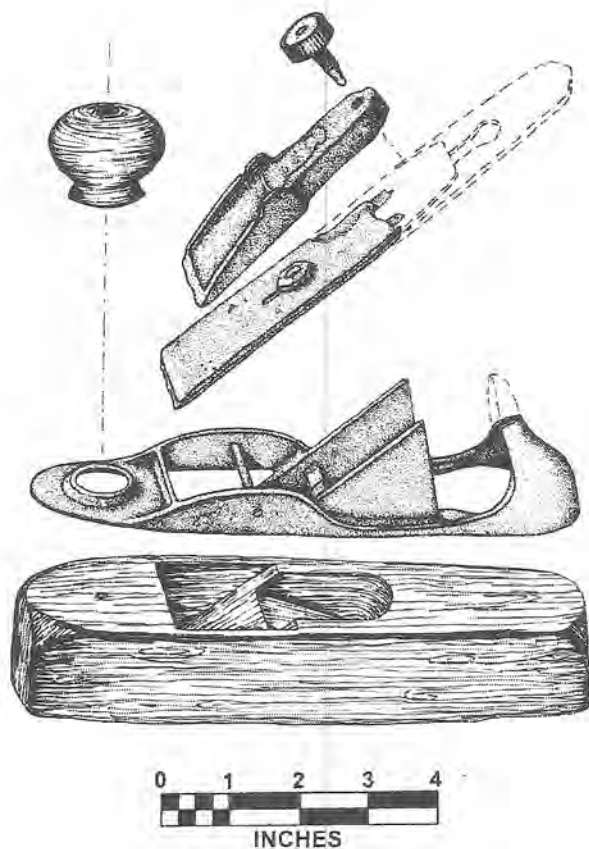
Figure 10. *Liberty Bell Plane (1886-1918) made by Stanley Rule & Level Company was found in a chest of drawers within the cabin of the Sloop Island vessel (LCMM Collection; drawn by Gordon Cawood and Adam Loven).*

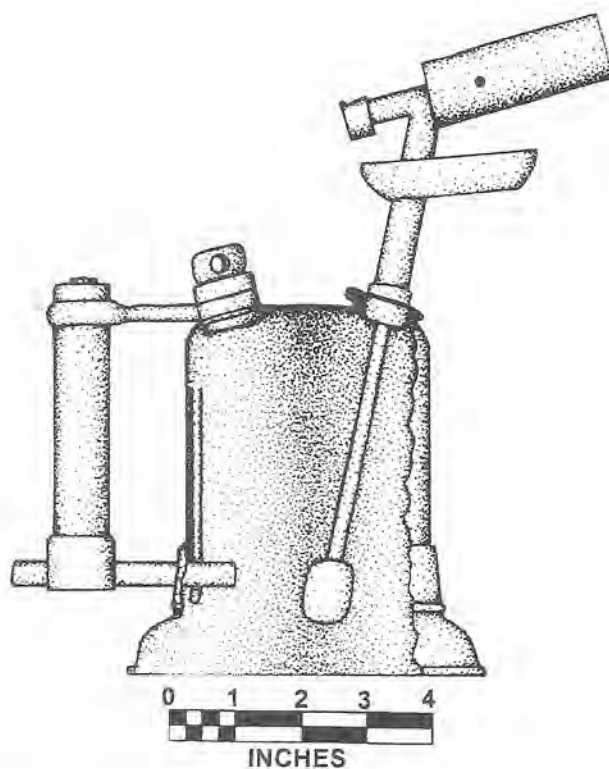
Figure 11. *Brass blowtorch found in the middle of the cabin floor of the Sloop Island vessel, likely used for melting pitch for caulking planking seams (LCMM Collection; drawn by Gordon Cawood and Adam Loven).*

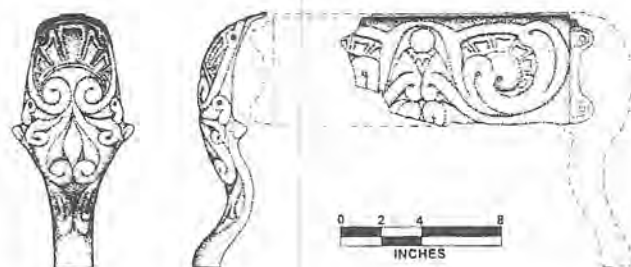
Figure 12. Stove skirt fragment and leg recovered from near the Sloop Island vessel's cook range, made by Liberty Stove Company, Philadelphia (LCMM Collection; drawn by Gordon Cawood and Adam Loven).

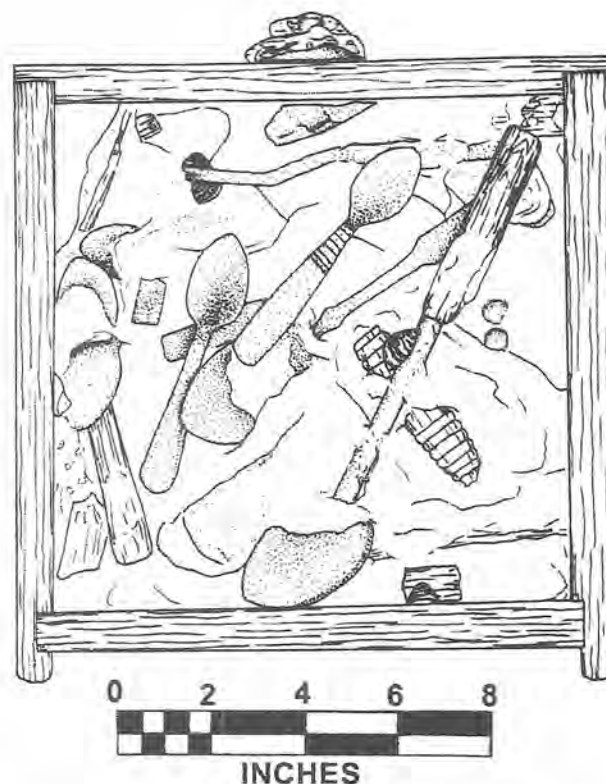
Figure 13. This drawer, found in the cabin near the stove, was once part of a cupboard. The drawer contained children's toy marbles, small buttons, door hardware, a cork screw, knives, forks, and spoons; some made by the Royal Manufacturing Company of Detroit (c. 1894-1908) (LCMM Collections; drawn by Adam Loven).

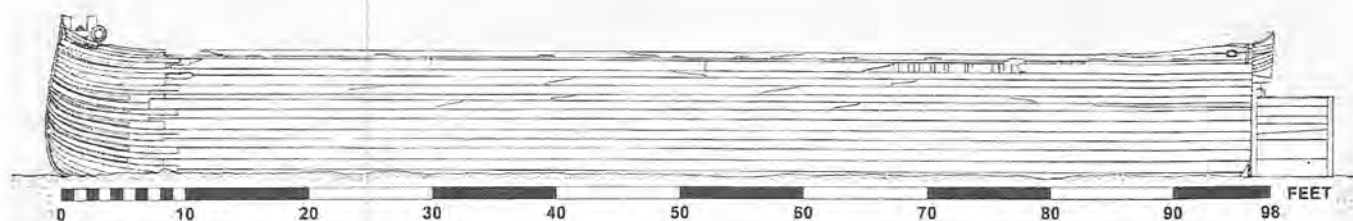
Figure 14. *Exterior profile of the Sloop Island Canal Boat* (LCMM Collection; drawn by Adam Kane, Chris Sabick, and Adam Loven).

The vessel's hull, like that of nearly all canal boats, is box-shaped with vertical sides, a flat bottom and blunt ends – a shape designed to carry as much cargo as possible within the confines of the size allowed by the canal locks. The Sloop Island vessel is 97 feet 3½ inches long, 17 feet 10 inches wide, and its depth amidships is 9 feet 10 inches (Figure 14).

The hull was built using “edge-fastening” construction, a technique often used to build canal boats from the 1840s onward. The primary characteristics of an edge-fastened hull are vertical sides held together by iron drift bolts driven

The hulls of canal boats with their high length-to-beam ratio, 5.5 to 1 in this case, were prone to hogging and sagging, or longitudinal disfigurement. Edge-fastened construction helped counter this tendency. The strength of an edge-fastened hull is largely derived from the vessel's sides, as opposed to “plank-on-frame” construction, the more traditional building technique, where the hull's strength comes from the skeleton-like internal framing. In plank-on-frame construction a ship's hull is commonly described as being akin to a human torso. The backbone of the ship is its keel, while its frames maintain

The canal boat's stern is much simpler in construction than the bow. The bottom portion of the stern is vertical, with planks oriented transversely. Unlike the vertical planks along the hull's side, the stern planks are not edge-fastened. Planks are rabbetted into the vertical sternpost. At the very bottom of the stern the planks abruptly curve from the vertical plane of the stern into the horizontal plane of the bottom of the hull. Above the vertical portion of the stern was a slightly curved transom that overhangs the lower part of the stern. The transom once had the vessel's name and homeport painted on it, but only small flecks of paint remain today on the Sloop Island vessel.

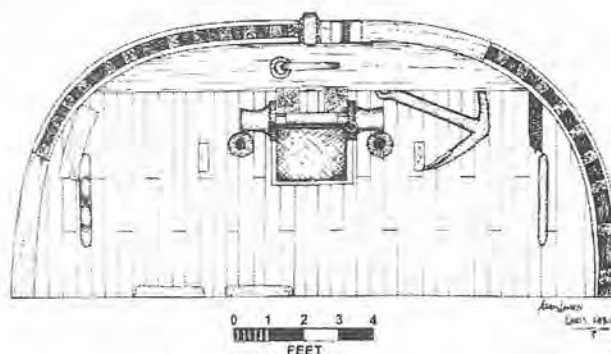
Figure 15. *Plan view of the Sloop Island Canal Boat's bow* (LCMM Collection; drawn by Chris Sabick and Adam Loven).

The canal boat's curved bow was built very differently from the rest of the hull. Due to its complex shape the bow was not edge-fastened, but was built using the more traditional shipbuilding technique of plank-on-frame construction. Overall, the bow is extremely bluff, with the planks fastened into the stem at a near 90° angle. The top of the stem is "raked," or angled, slightly aft, creating a recessed area where a lantern could be hung. The exterior of the bow is reinforced with eight rubrails; the leading edge of each is covered with an iron band. These were used to limit wear from frequent abrasion with other canal boats, and the canal locks and prism. The bow was constructed primarily of white oak and elm, as opposed to much of the rest of the hull, which was white pine.

Access to the forecabin, or the interior of the bow, was gained through the forecabin hatch (Figure 15). The forecabin was separated from the hold and its cargo by a tongue-and-groove plank bulkhead. Several feet of silt have accumulated in the bow of the Sloop Island vessel, making the study of this area difficult. Many boat-related artifacts such as a broken capstan, a roll of tar paper, a paint pot with a brush, a marlin spike, an iron block, and numerous iron fasteners were found

here, indicating that it served as a storage area for tools and other equipment. Many items were still sitting on top of the large breasthooks; it is likely that many other pieces of boat-related equipment remain buried below the sediments.
